Investigation of Microcracking and Damage Propagation in Cross-Ply Composite Laminates

INVESTIGATION OF MICROCRACKING AND DAMAGE PROPAGATION IN CROSS-
PLY COMPOSITE LAMINATES

A Thesis

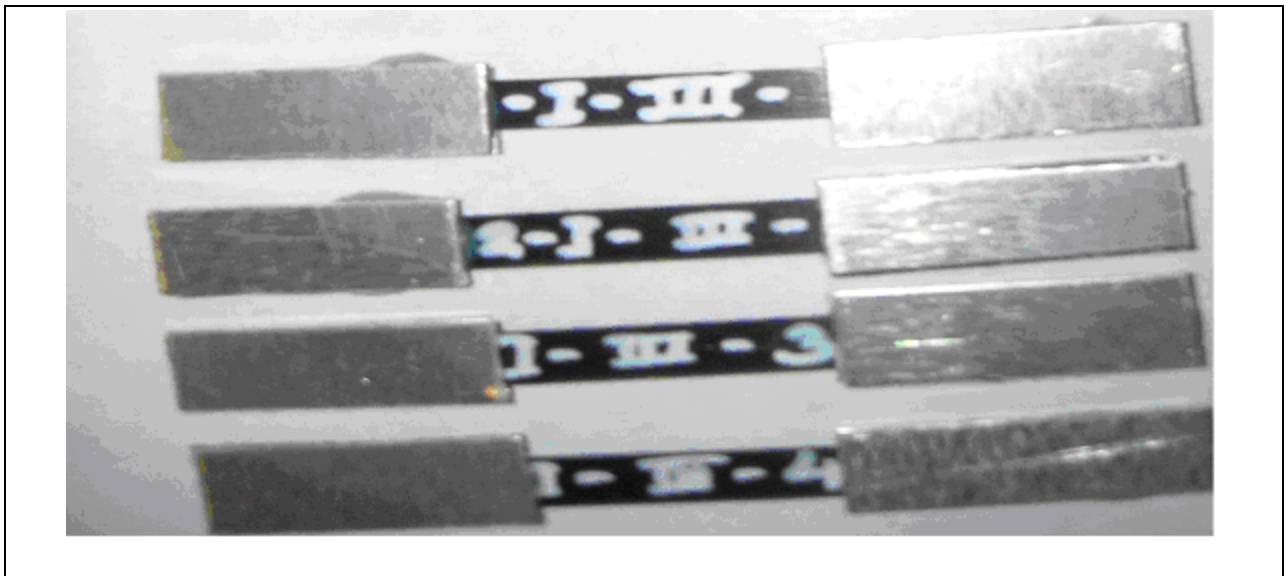
Figure 3.1 Specimens after Preparation

10mm x 20mm pieces. The specimen was glued using Loctite E-120HP Hysol epoxy adhesive. Before gluing the specimen the surfaces of the specimen and the aluminum tabs were made rough using 2-100 medium sand paper to ensure perfect bonding. The glue was mixed using a static mixer. An optimal quantity was used so that the glue itself does not fail under shear load. The glued specimen was cured at room temperature eight to ten hours before testing. Figure 3.1 shows four specimens after preparation.

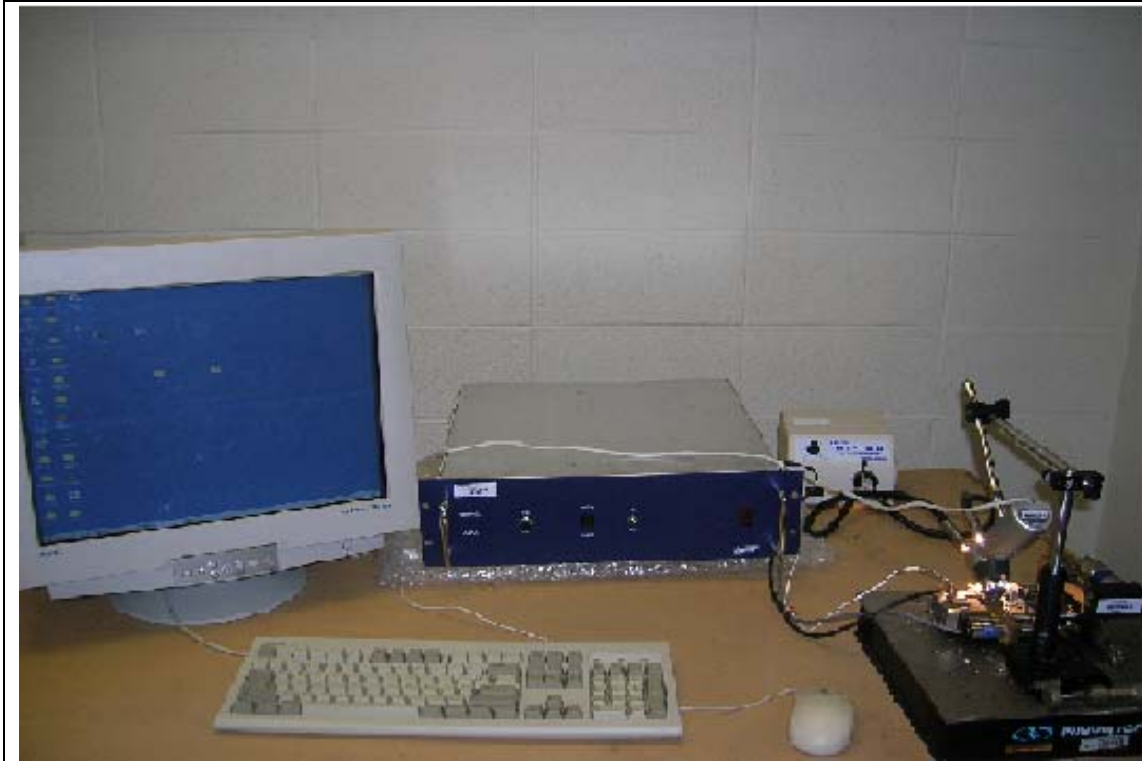
Figure 3.2 Experimental Setup.

Tensile testing was done using 2000 lb capacity tensile substage. The test setup comprises of a tensile substage, data acquisition system and mechanical testing software MTestWindows supplied by ADMET, Inc. Figure 3.2 depicts the experimental setup. Figure 3.3 shows a close-up view of a specimen in the substage.

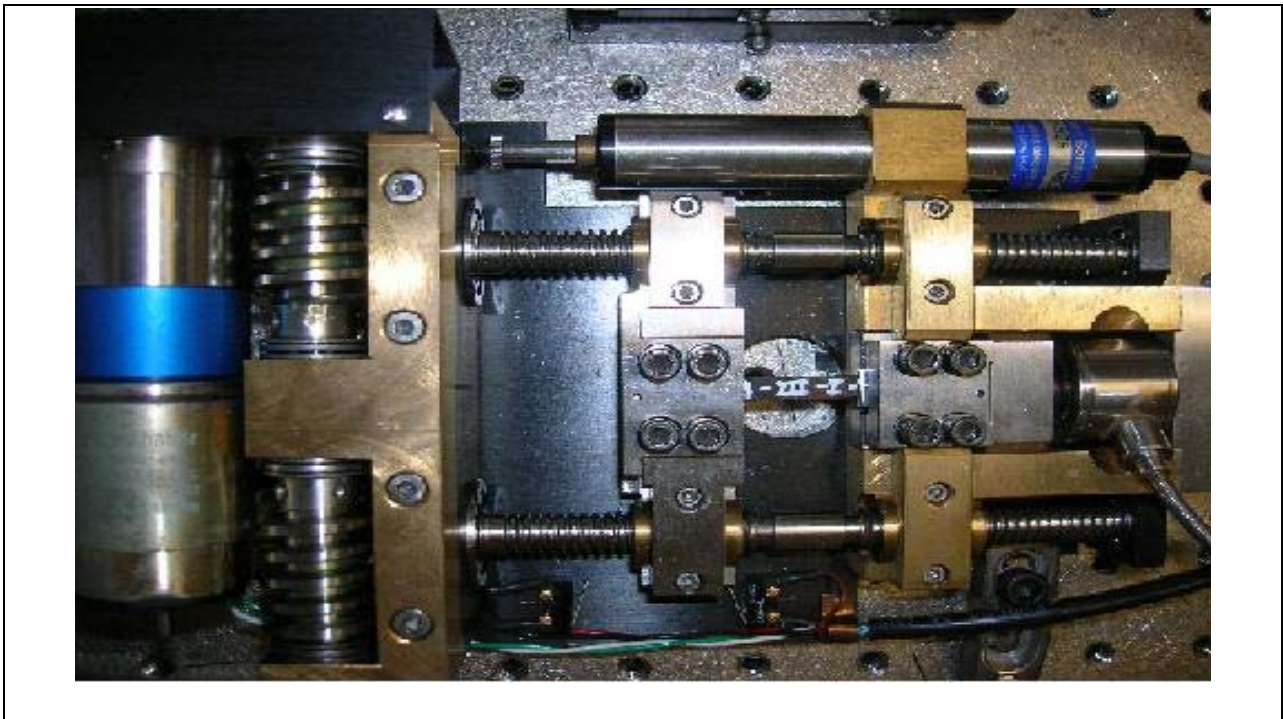
Figure 3.3 Close-up view of a Specimen in the Substage.

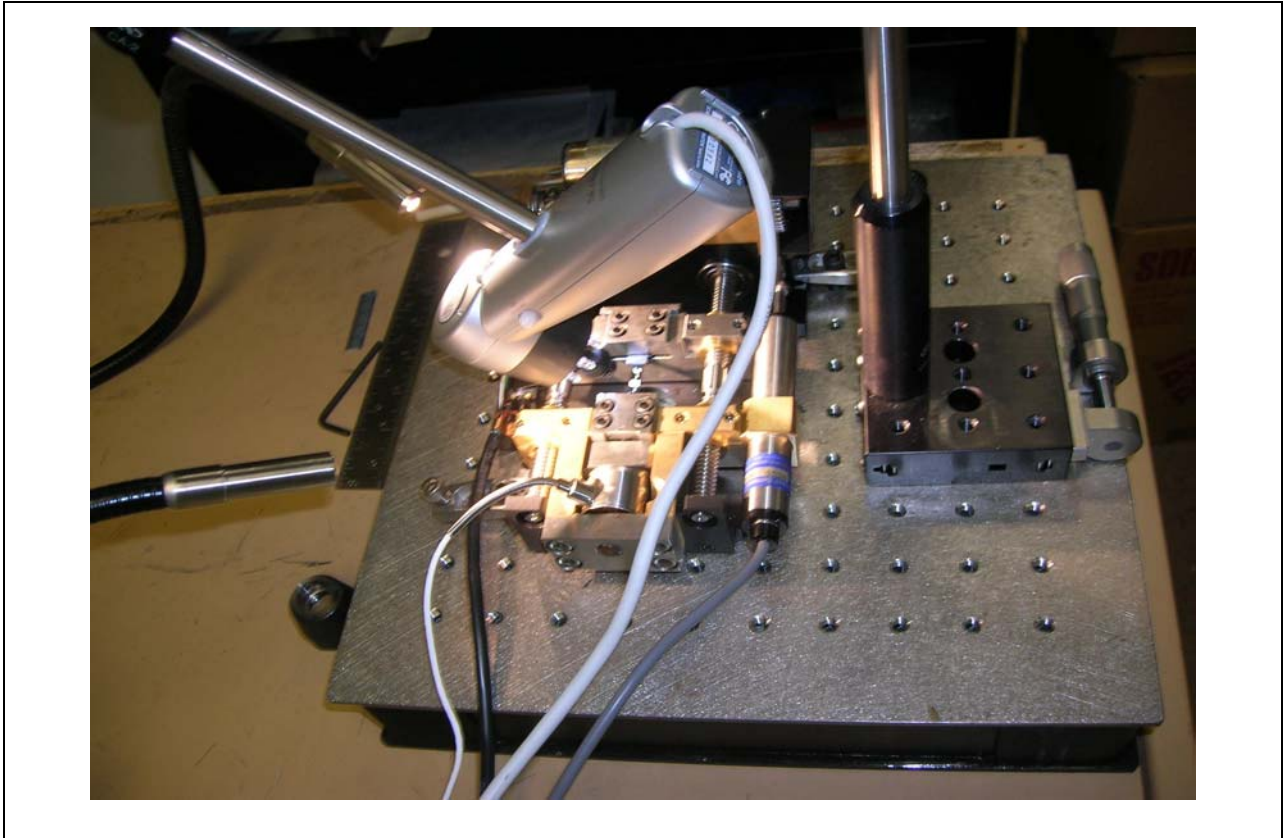
Figure 3.8 Optical Microscope Setup.

the micrographs are obtained will be referred to as the optical span length. A high intensity illuminator was used to brighten the surface under investigation to get good results. Figure 3.8 is a picture of the optical microscopy setup.

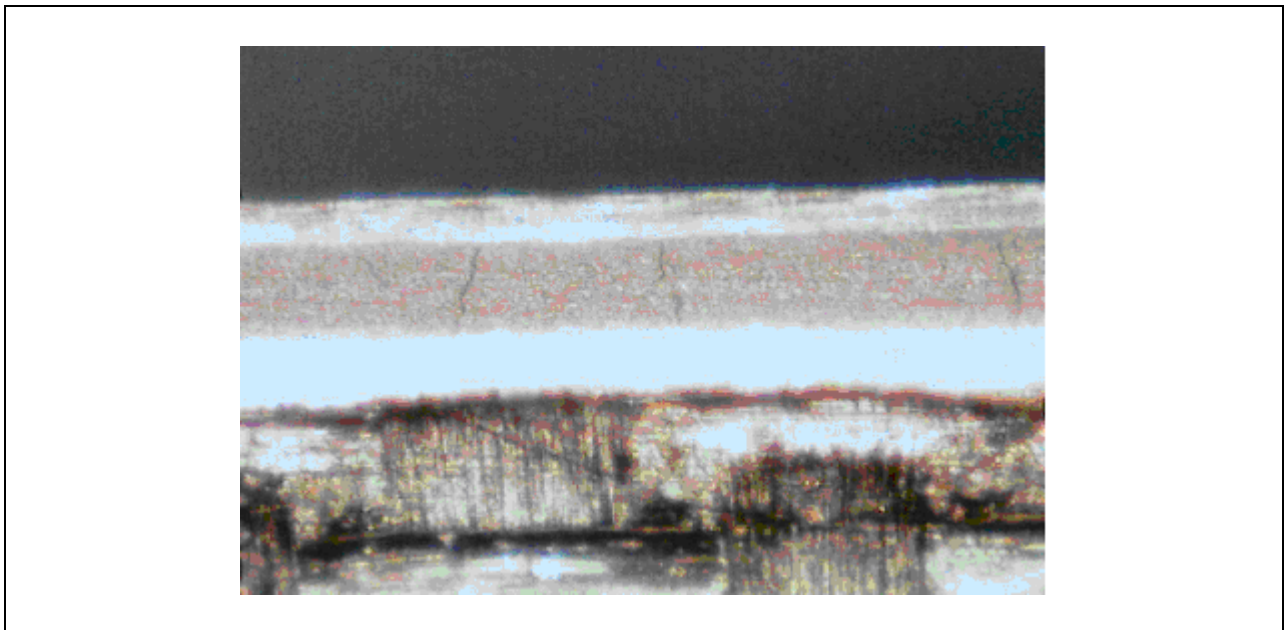
Figure 3.9 Optical Micrograph

As previously noted, the specimen length in the field of view of a single micrograph is 1.375mm. Each of these images is captured with 640 horizontal and 480 vertical pixels. The snapshots from each stress level are grouped together and the number of microcracks for the optical scan length is counted. Note that this process is a bit tedious since there is an overlap length of 0.125mm between consecutive micrographs. Then by using a zooming software tool, ZoomMagic, the number of pixels between each crack is determined. Figure 3.9 displays a typical optical micrograph and Figure 3.10 displays the screen shot of the ZoomMagic software.

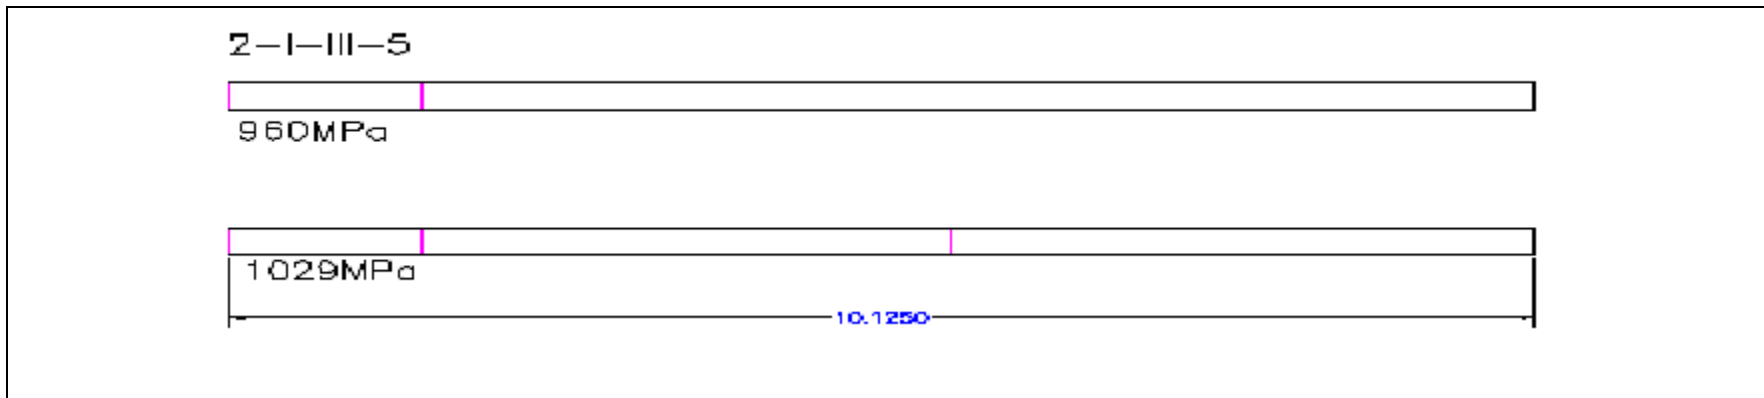
Figure 4.1 Schematics of Crack Propagation in Specimen 2-I-III-5.

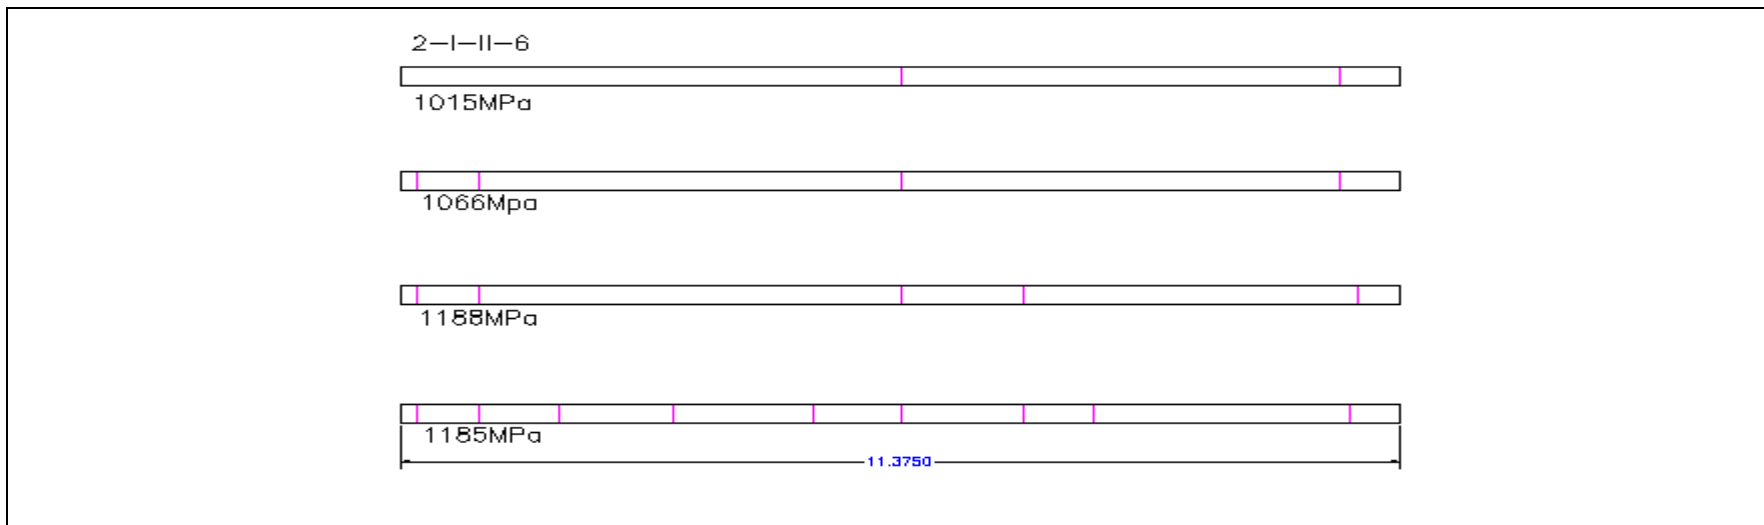
Figure 4.2 Schematics of Crack Propagation in Specimen 2-I-III-6.

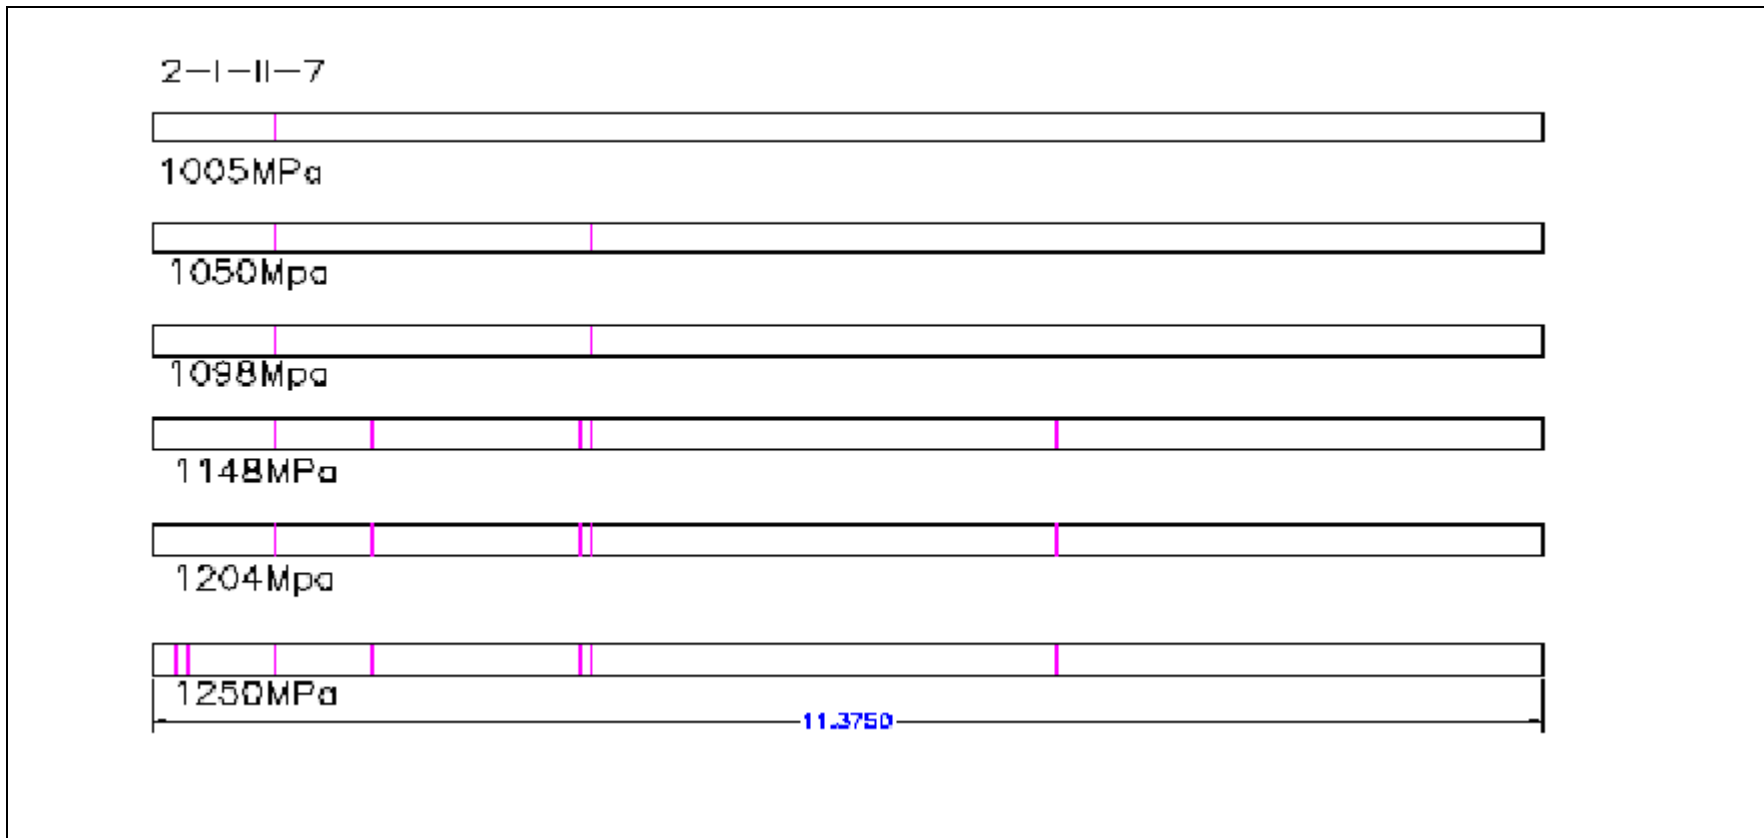
Figure 4.3 Schematics of Crack Propagation in Specimen 2-I-II-7.

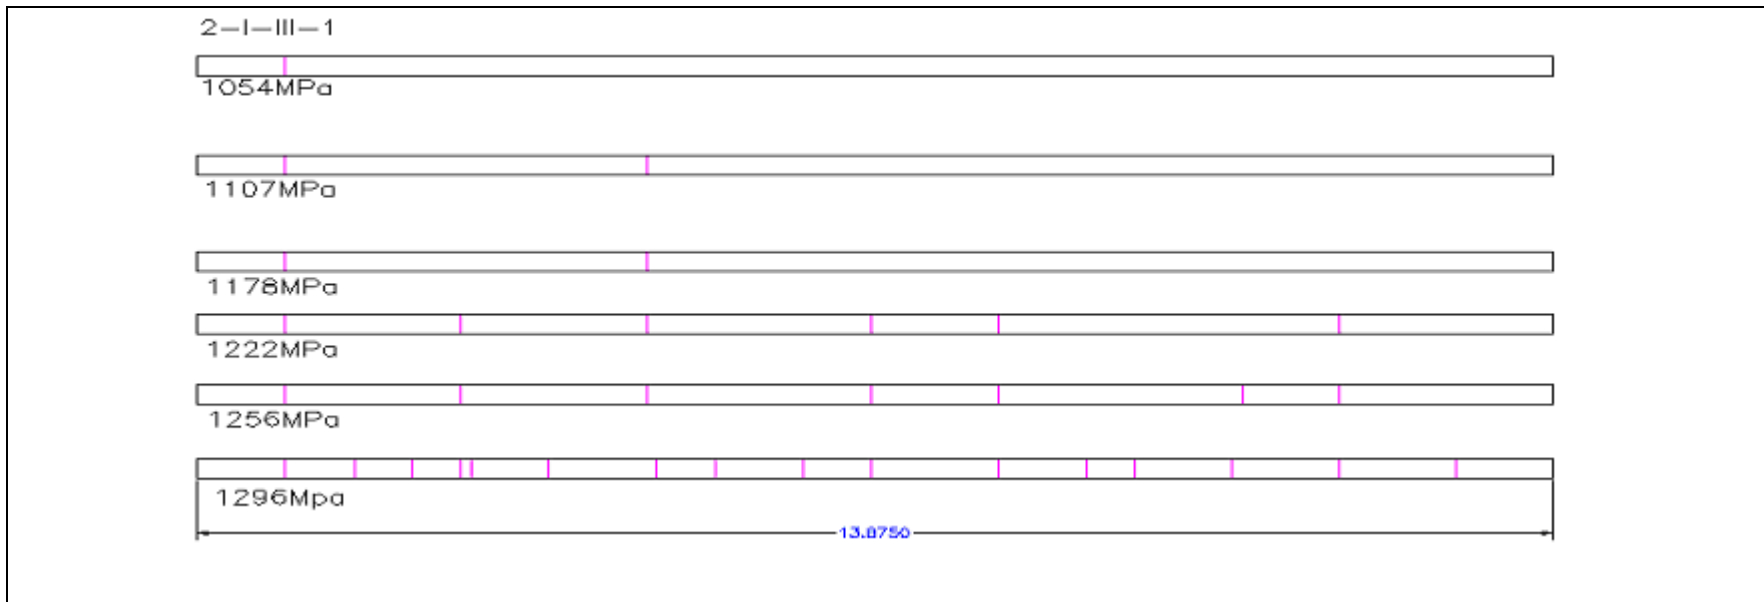
Figure 4.4 Schematics of Crack Propagation in Specimen 2-I-III-1.

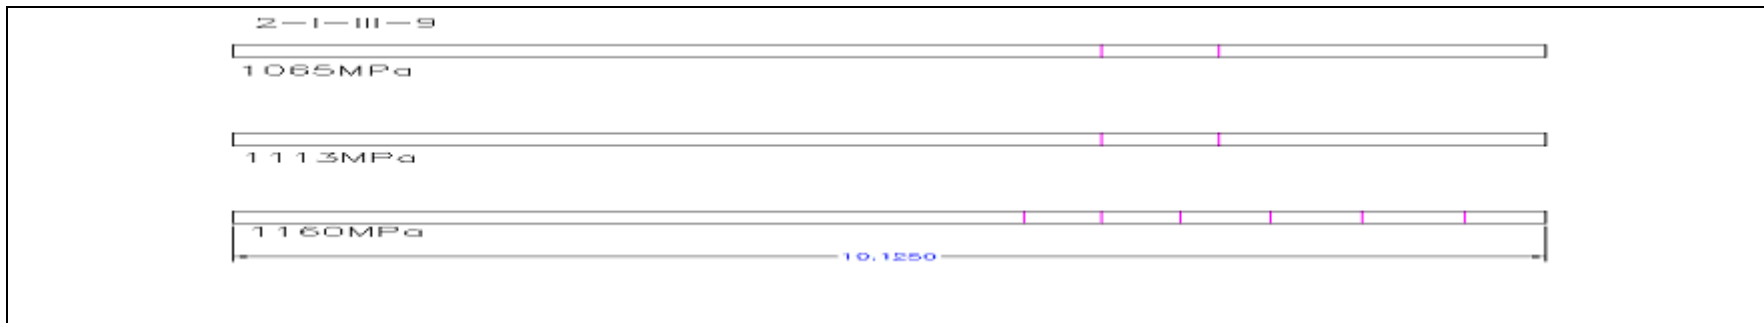
Figure 4.5 Schematics of Crack Propagation in Specimen 2-I-III-9.

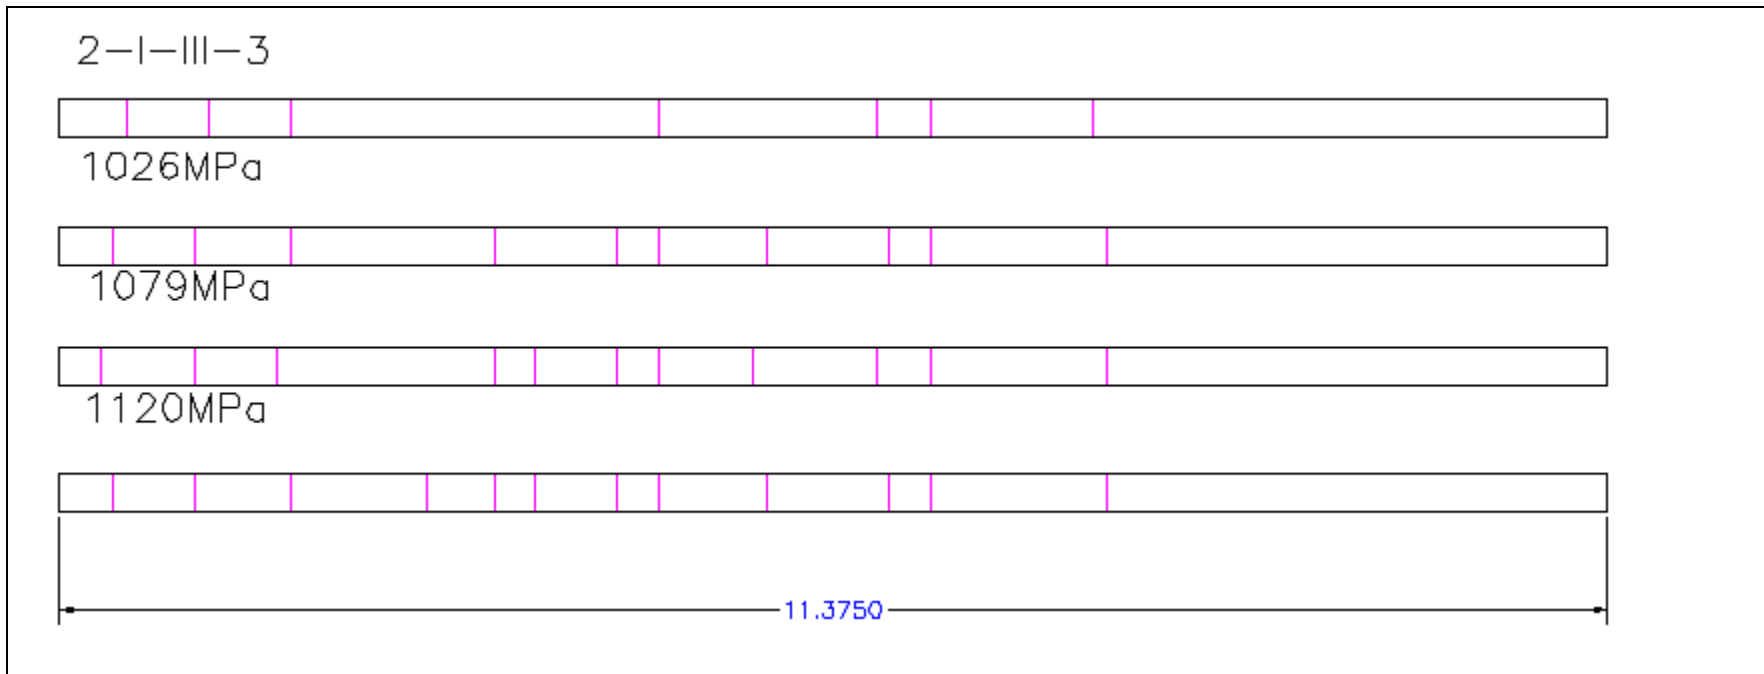
Figure 4.6 Schematics of Crack Propagation in Specimen 2-I-III-3.

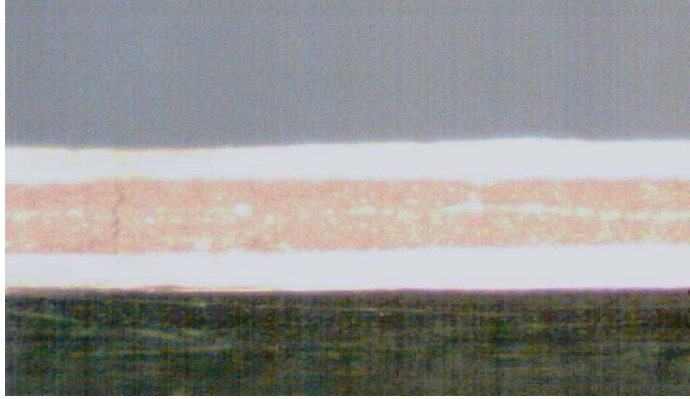
Specimen	Micrograph	Damage Load (MPa) and Discussions
2-I-II-5

<p>Specimen 2-I-II-5 did not show any other form of other damage under optical microscope and the specimen failed at 1133MPa. The picture in the left shows the micrograph with a single microcrack at 1087MPa. The specimen failed near the tabs.</p>
2-I-II-6

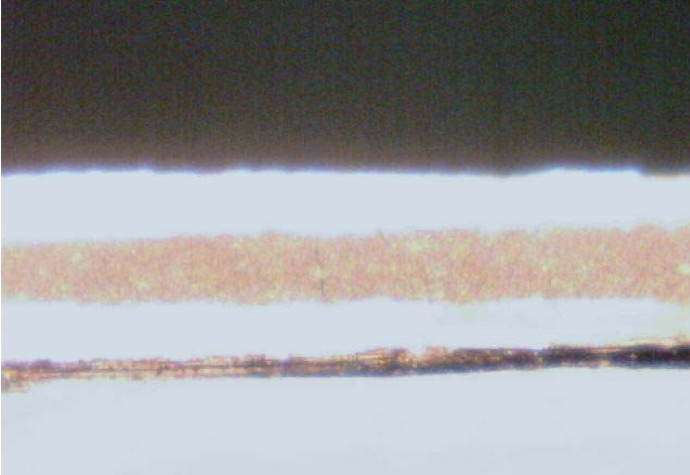
<p>Specimen 2-I-II-6 did not show any other form of other damage under the optical microscope and the specimen failed at 1222MPa. The picture in the left shows the micrograph with a single microcrack at 1185MPa. The specimen failed into two pieces in the mid span.</p>

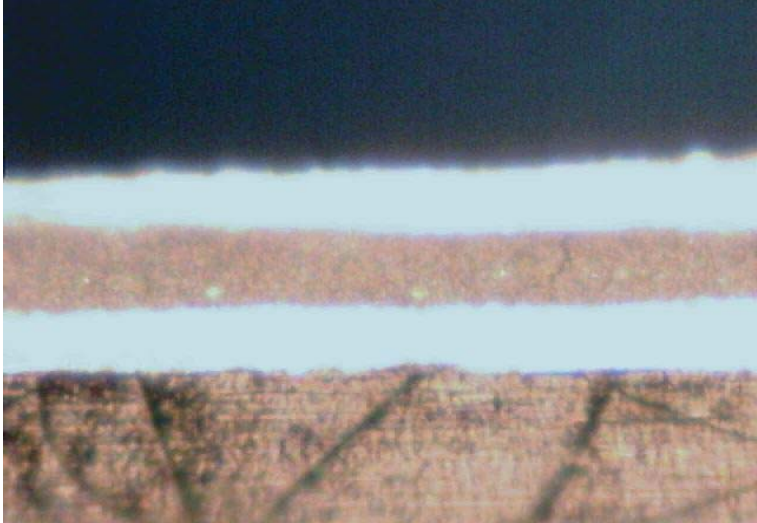
<p>2-I-II-7</p>

<p>Specimen 2-I-II-7 did not show any kind of other damage before failure. The specimen failed at a load of 1266MPa. The specimen failed near the tabs. The micrograph in the left shows the micrograph at the load of 1250MPa.</p>
<p>2-I-III-1</p>

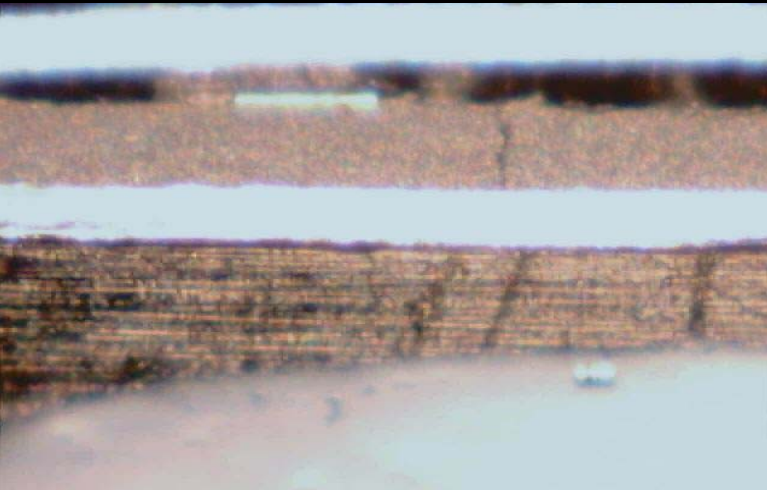
<p>The micrograph to the left is from specimen 2-I-III-1 at 1297MPa. Delamination was observed at a load of 1297MPa. The specimen failed at the ends of the tabs with additional load of 25MPa.</p>

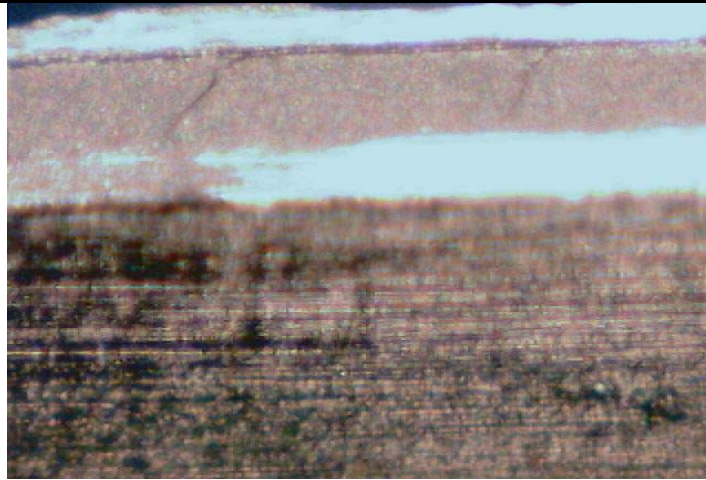
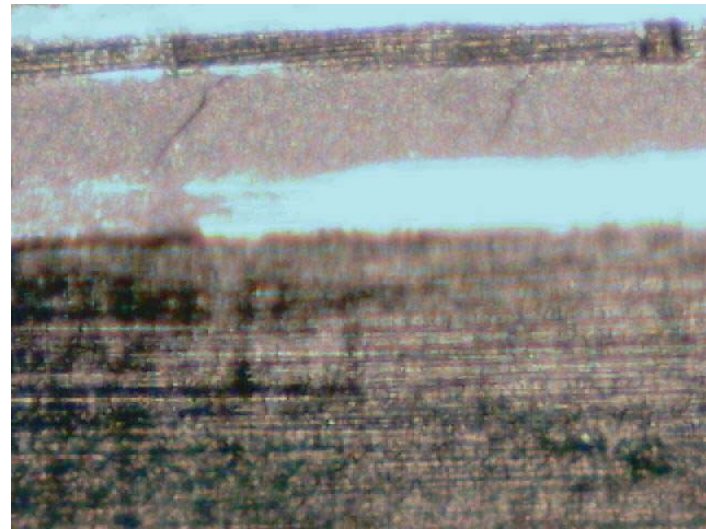
The micrographs in the left are from specimen 2-I-III-3 at load of 1026MPa and 1172MPa. It can be seen that there are two microcracks in both micrographs. Delamination was observed at a load of 1026MPa. The specimen failed at a load of 1208MPa. In the top picture and as the load increases the delamination increases between the 0° ply and 90° plies.

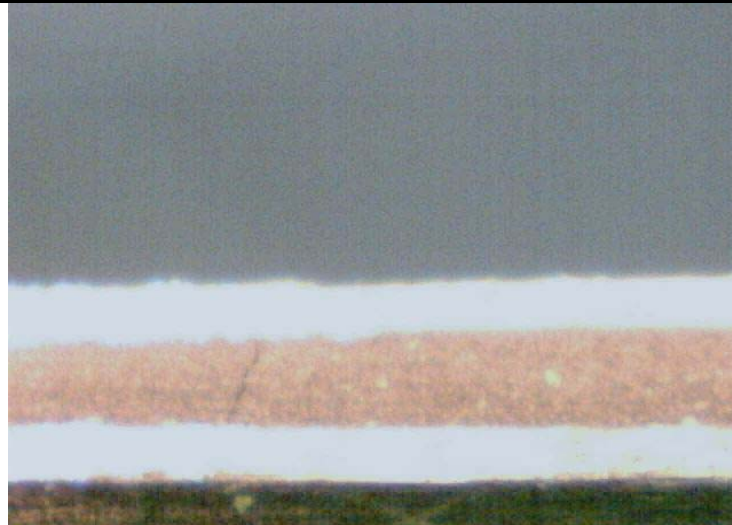
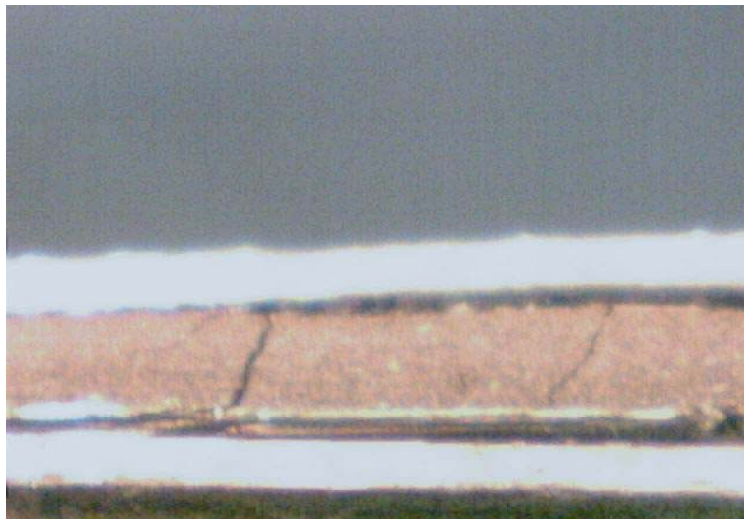
The figures in the left show the micrograph of specimen 2-I-III-9 at loads of 1113MPa (top) and 1160MPa (bottom). At 1113MPa no other form of damage was observed other than a single microcrack. At 1160MPa the specimen started delaminating between the 0° plies and 90° plies in the upper ply group. Fiber pull-out in the lower ply group between the 90° and 0° plies was also observed. There is also an additional new microcrack and they both provide contact delamination. This specimen immediately failed into two pieces at an additional load of 20MPa.

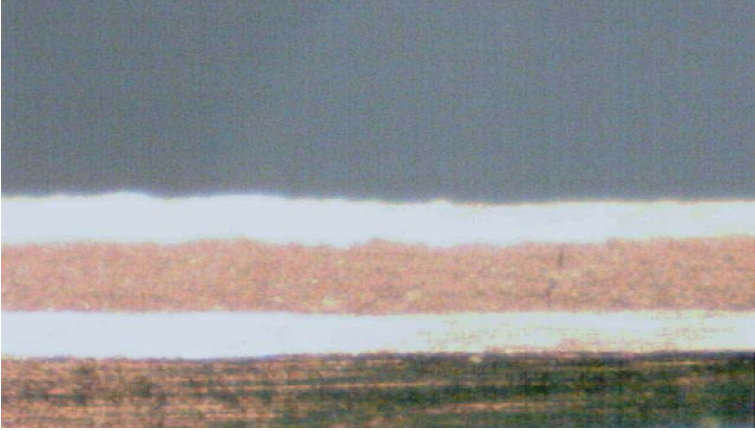
Specimen 2-I-III-4 did not show any other forms of damage under the optical microscope. The test was stopped at 1151MPa.
2-I-III-5

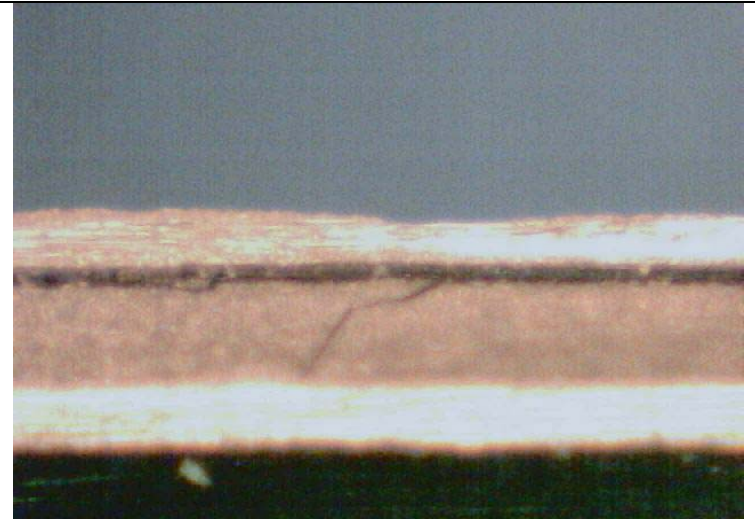
Specimen 2-I-III-5 started to delaminate at a load of 1156MPa, as seen in the micrograph. The test was stopped.

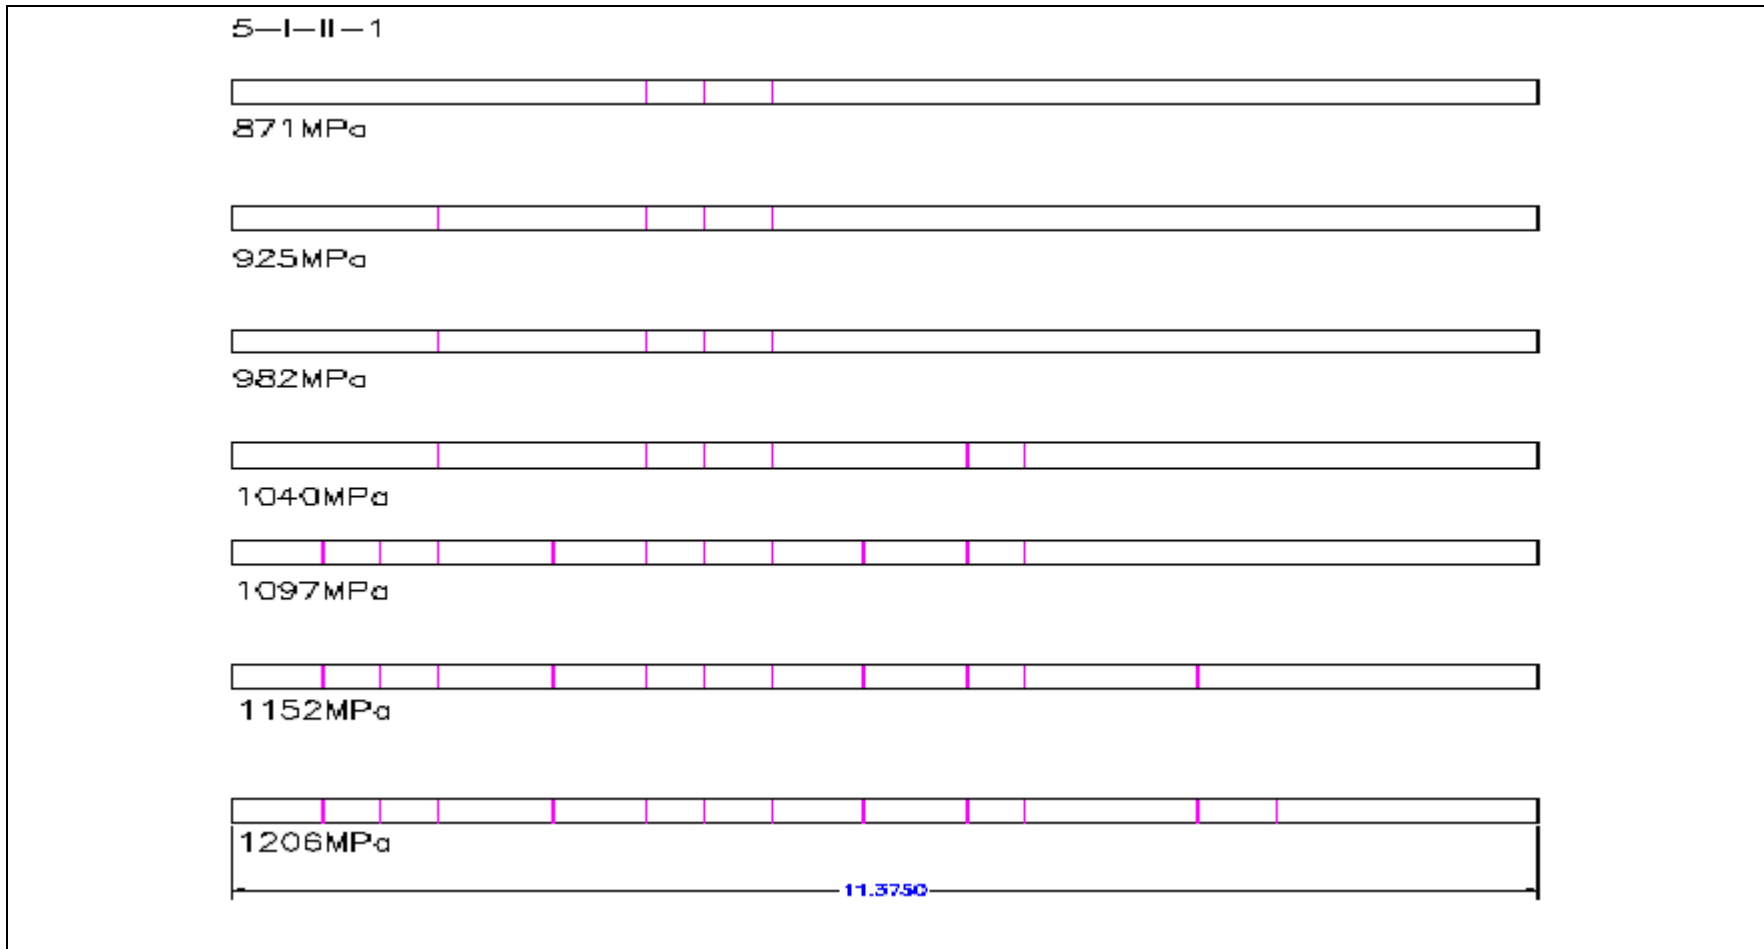
Figure 4.7 Schematics of Crack Propagation in Specimen 5-I-II-1.

Figures 4.7 through 4.12 display schematics of crack formation for six IM7/5555 specimens tested to failure. All the specimens had an optical span length of 11.375mm under the optical microscope. The material system IM7/5555 started microcracking in the mid-span of the specimen, as expected. Five of the specimens displayed the same number of maximum microcracking in the span of 11.375mm resulting in a crack density of 16.7cracks/cm. The cracks were more evenly distributed throughout the length of the specimen than those of the IM7/977-2 specimens.

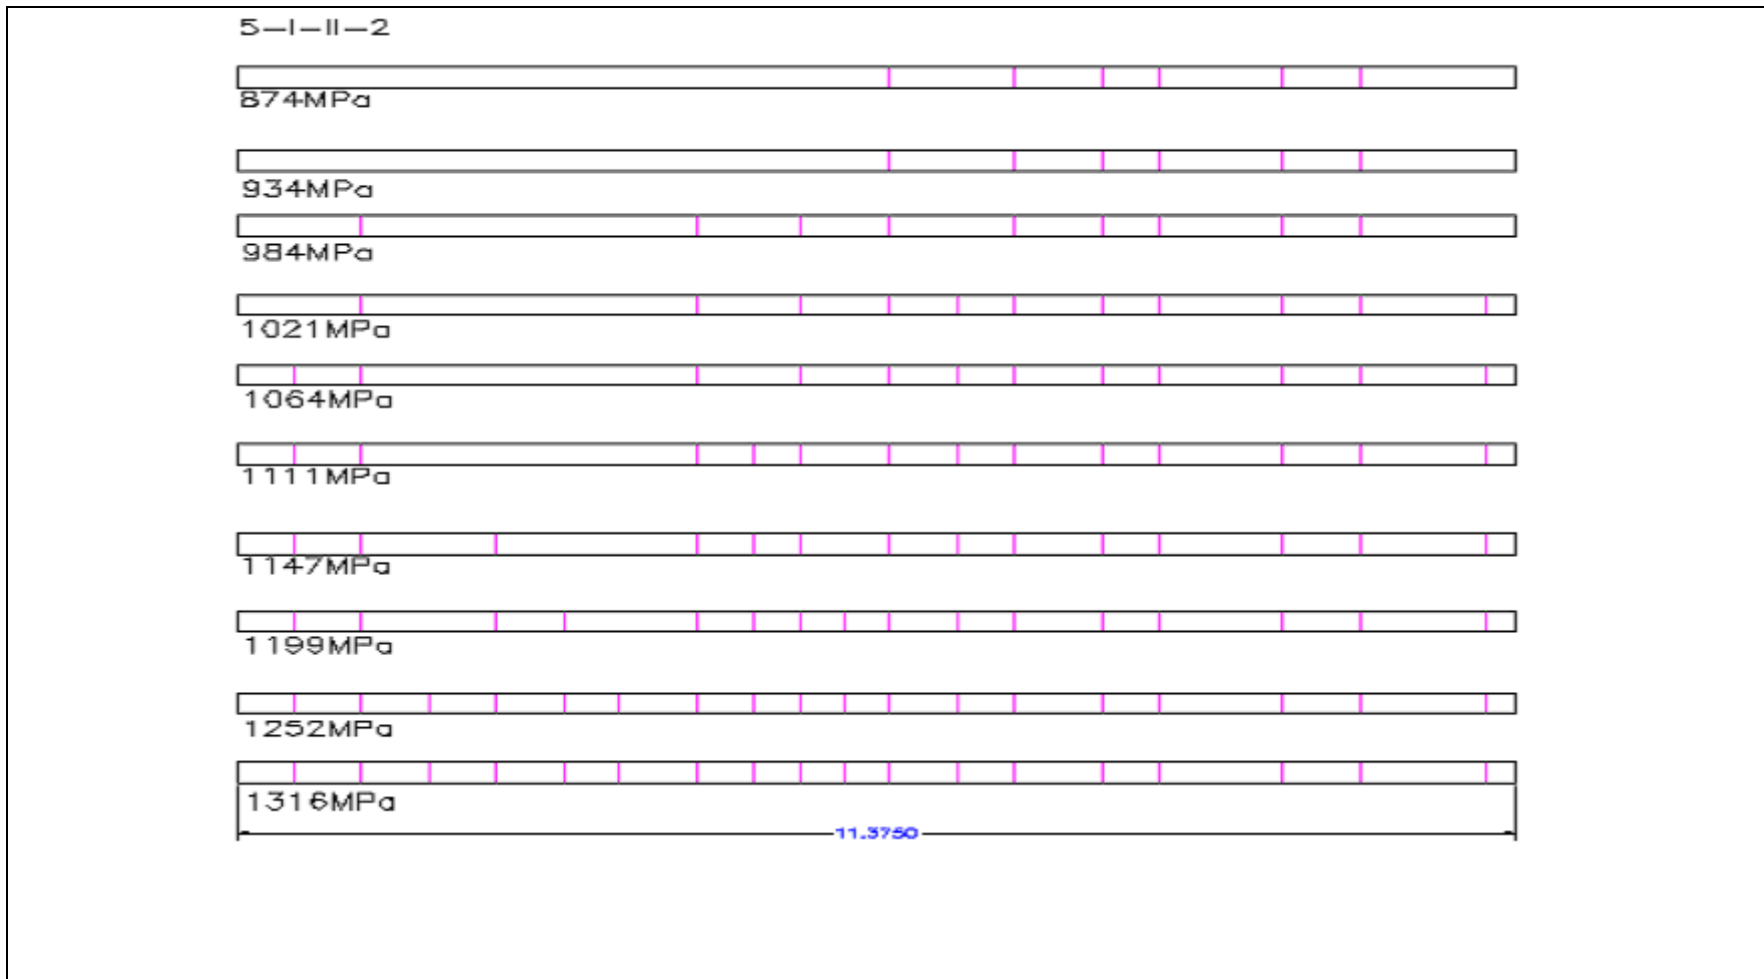
Figure 4.8 Schematics of Crack Propagation in Specimen 5-I-II-2.

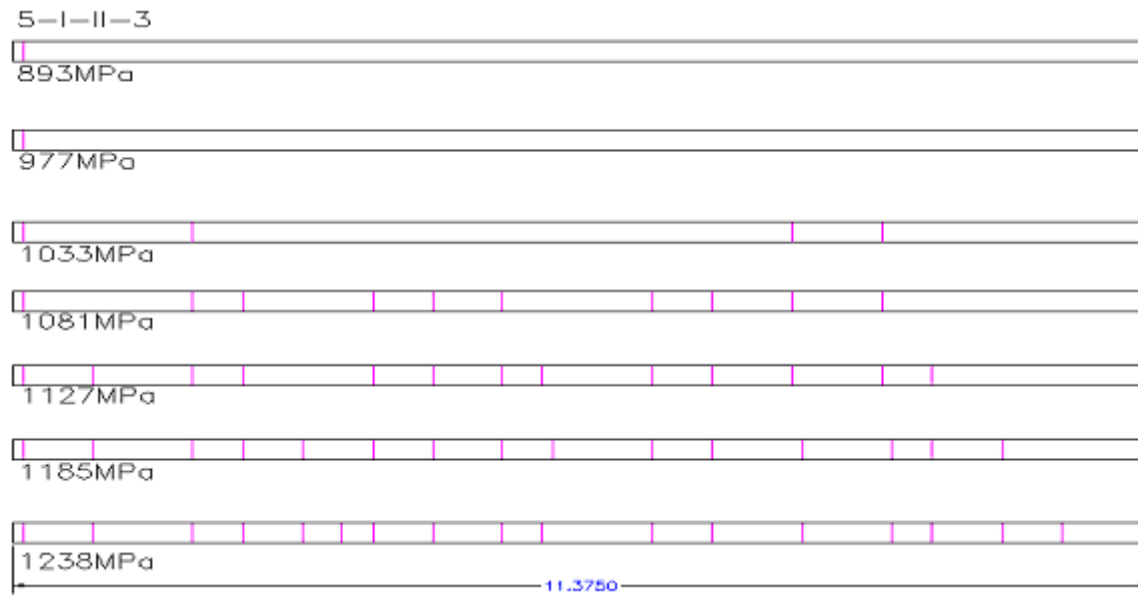
Figure 4.9 Schematics of Crack Propagation in Specimen 5-I-II-3.

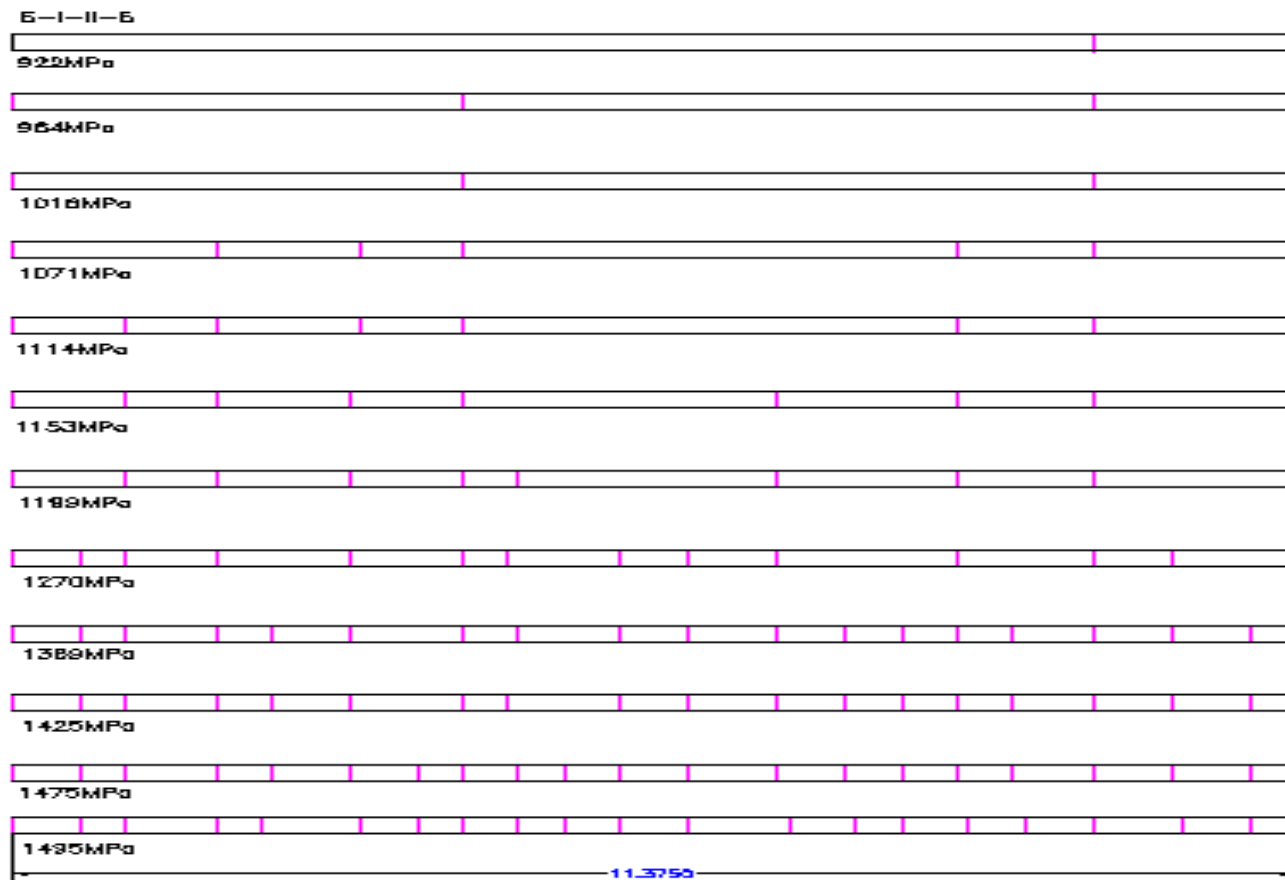
Figure 4.10 Schematics of Crack Propagation in Specimen 5-I-II-5.

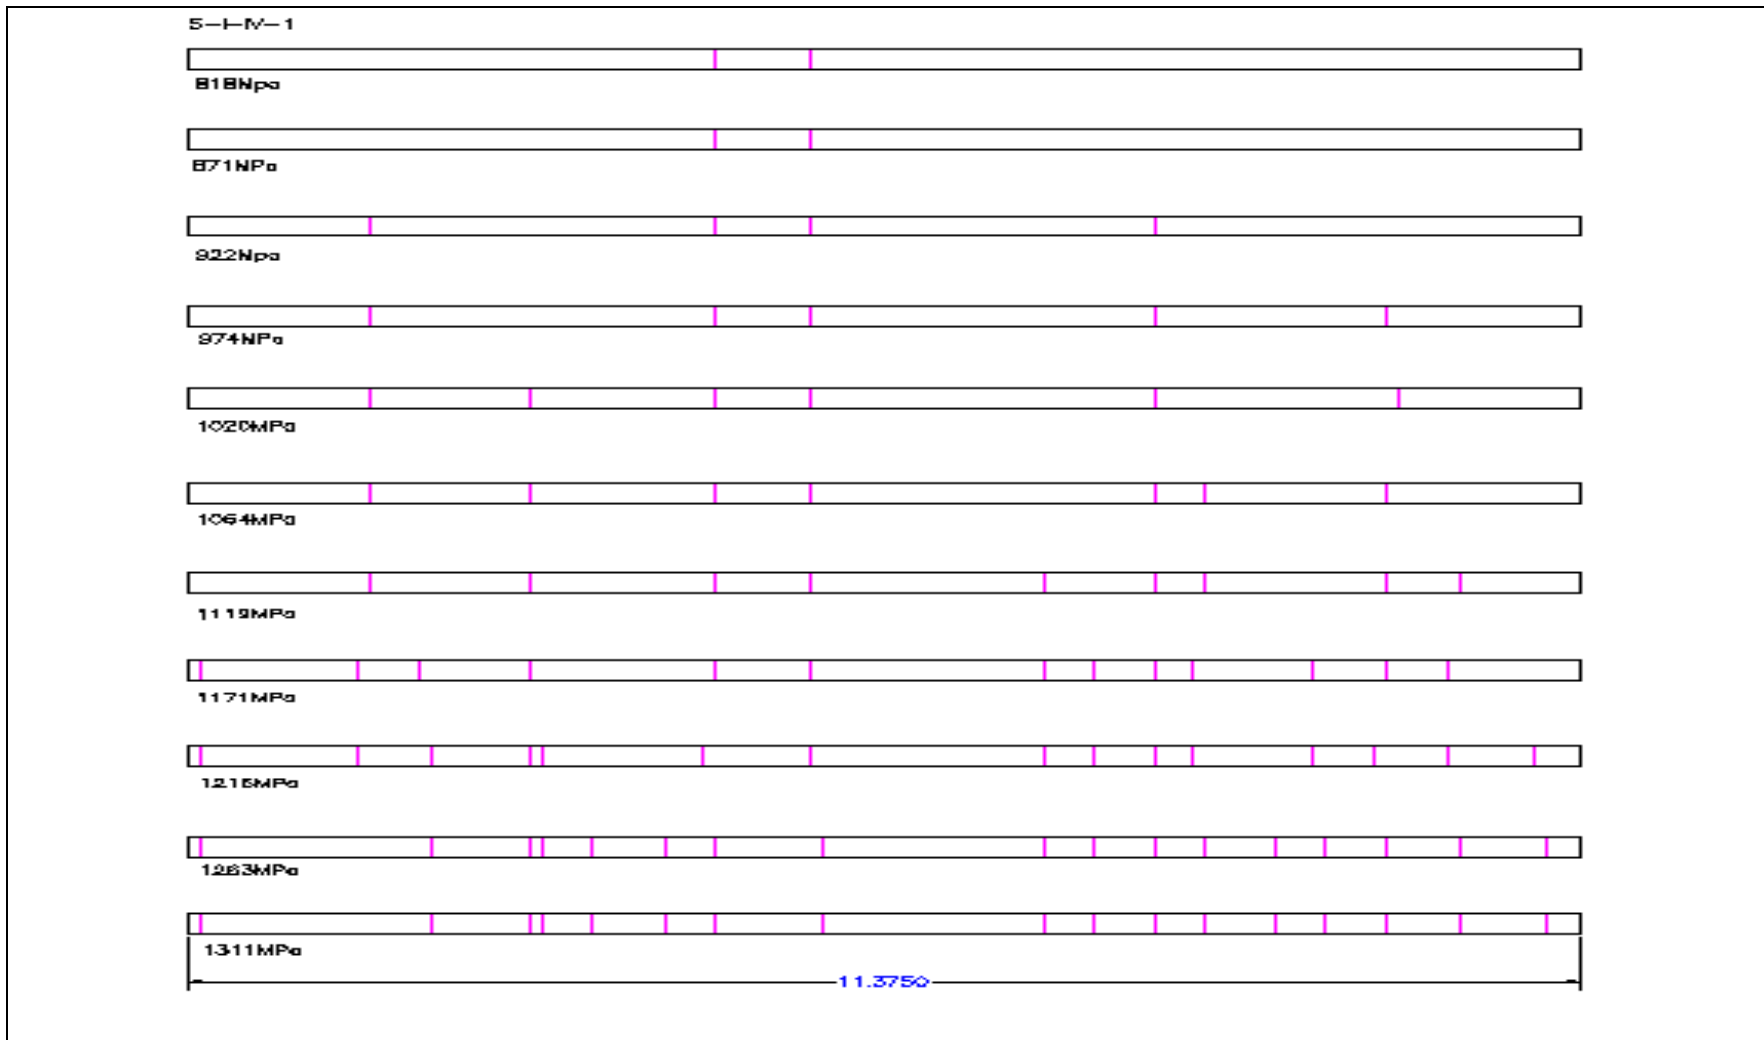
Figure 4.11 Schematics of Crack Propagation in Specimen 5-I-IV-1.
