Investigation of Microcracking and Damage Propagation in Cross-Ply Composite Laminates

INVESTIGATION OF MICROCRACKING AND DAMAGE PROPAGATION IN CROSS-
PLY COMPOSITE LAMINATES

A Thesis

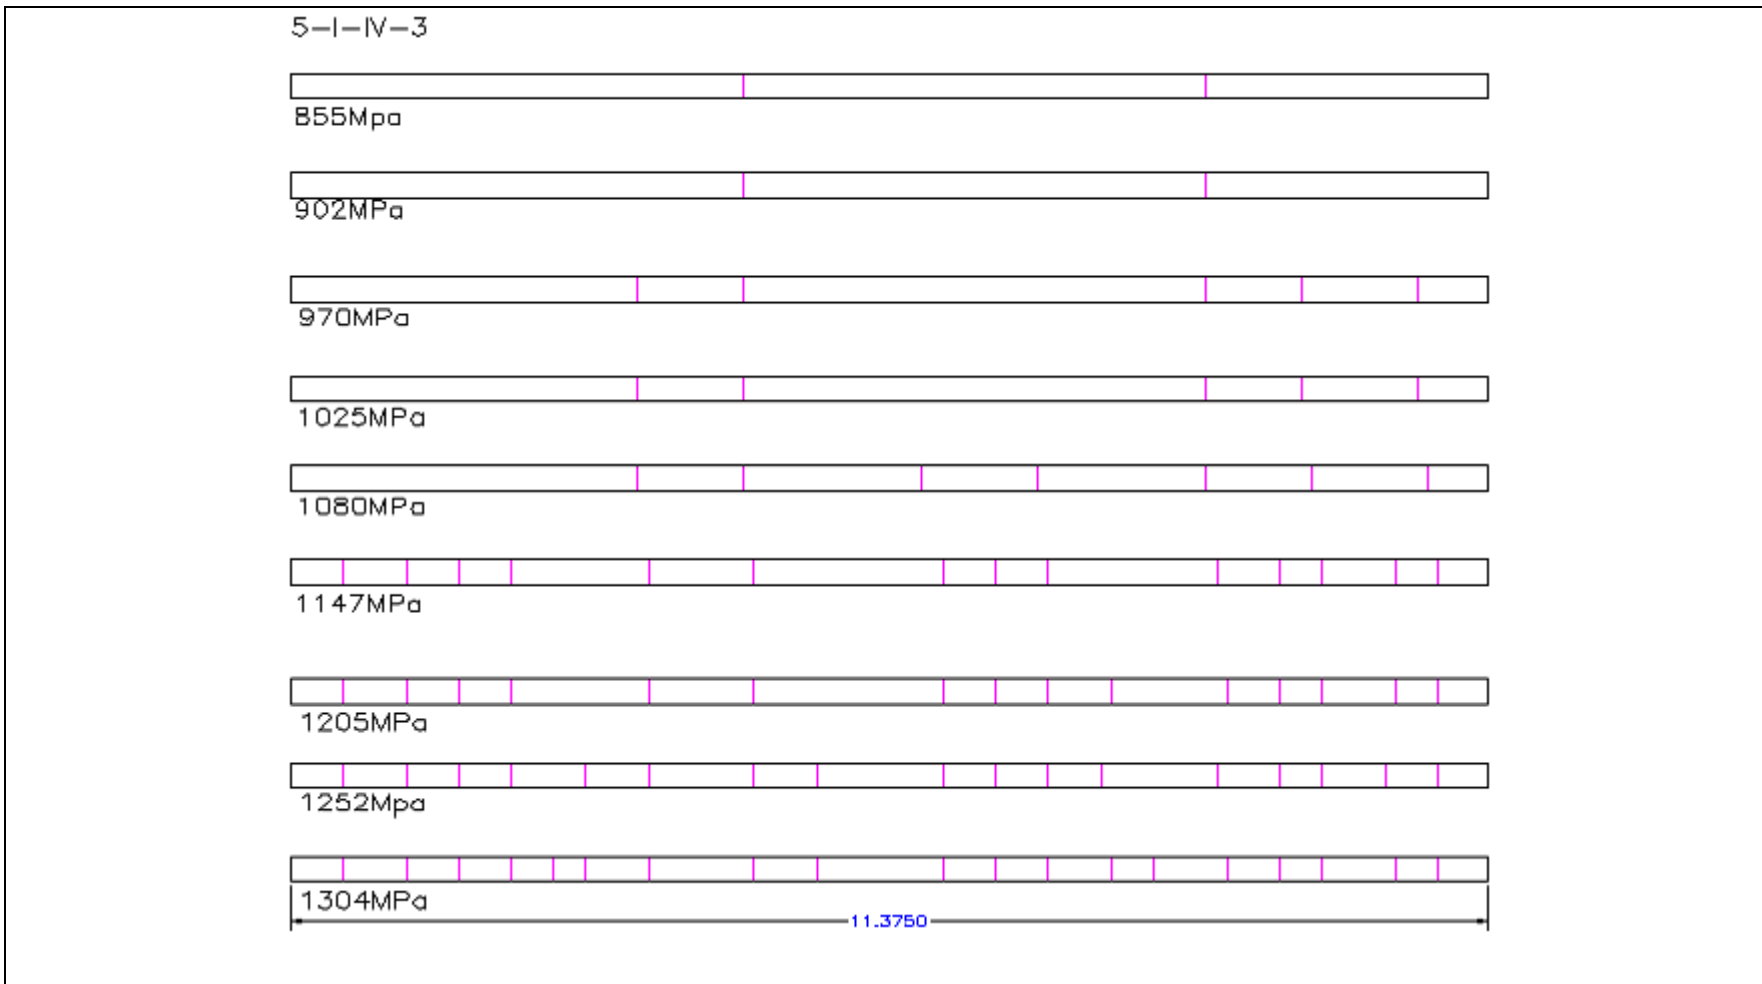
Figure 4.12 Schematics of Crack Propagation in Specimen 5-I-IV-3.

Figures 4.7 through 4.12 display schematics of crack formation for six IM7/5555 specimens tested to failure. All the specimens had an optical span length of 11.375mm under the optical microscope. The material system IM7/5555 started microcracking in the mid-span of the specimen, as expected. Five of the specimens displayed the same number of maximum microcracking in the span of 11.375mm resulting in a crack density of 16.7cracks/cm. The cracks were more evenly distributed throughout the length of the specimen than those of the IM7/977-2 specimens.

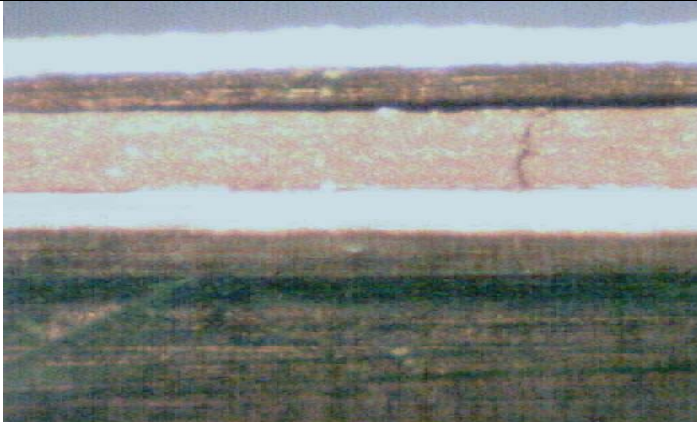
Specimen	Micrograph	Damage Load(MPa) and Discussions
5-I-II-1

<p>The micrograph is taken at a load of 1206MPa. Delamination was observed in the specimen at a load of 1040MPa. The specimen broke into pieces at failure.</p>
5-I-II-2

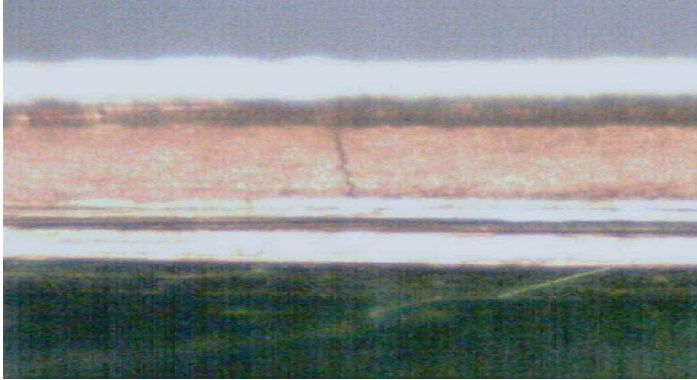
<p>The micrograph is taken at a load of 1316MPa. It can be seen from the micrograph there is fiber pull-out and delamination between the 90° plies and the 0° plies. Delamination was observed in the specimen at the load of 1021MPa. The specimen failed into pieces at failure.</p>

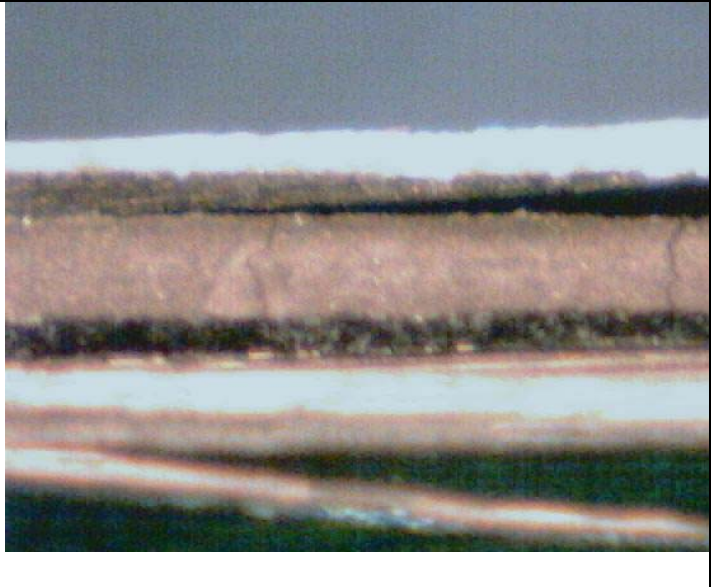
5-I-II-3

<p>This is taken at a load of 1352MPa. It can be seen from the micrograph, there is fiber pull-out and delamination in the specimen. Delamination was observed in the specimen at a load of 1081MPa. The specimen failed into pieces.</p>
5-I-II-5

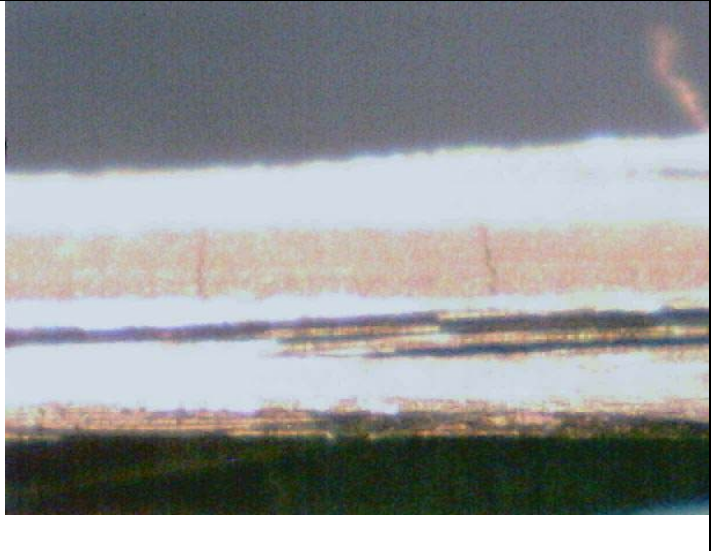
<p>The micrograph was taken at a load of 1495MPa. In the micrograph it can be seen the specimen developed fiber pull-out in the edges of the specimen and the specimen failed into pieces at failure.</p>

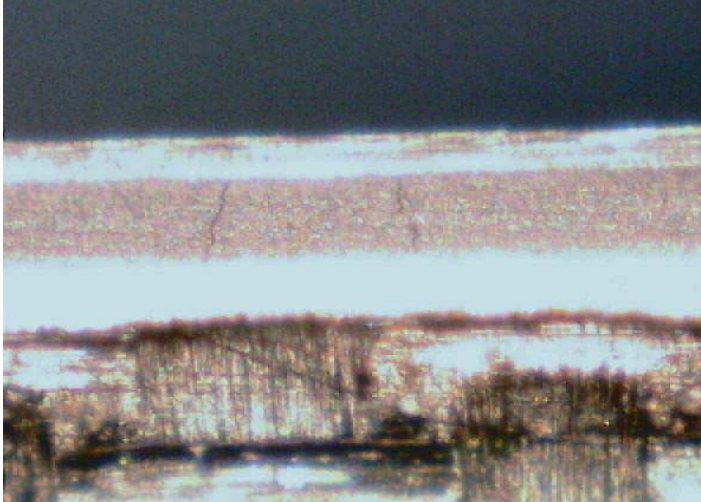
5-I-IV-1

<p>The micrograph was taken at a load of 1304MPa. The specimen developed 3 microcracks at this location. The micrographs did not show other kind of damage before failure. At failure, the specimen into broke into pieces.</p>
5-I-IV-3

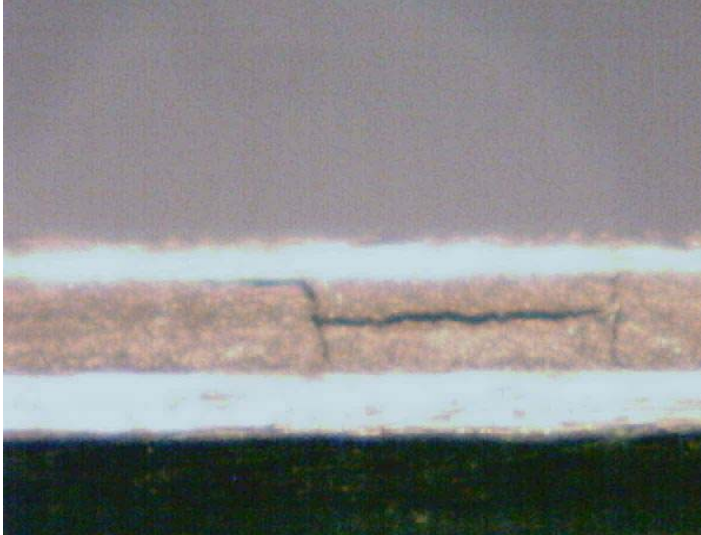
<p>The micrograph was taken at a load of 1311MPa. The specimen developed delamination between the two 90° plies and some delamination in other locations between the 0° plies and 90°. This specimen failed immediately into pieces.</p>

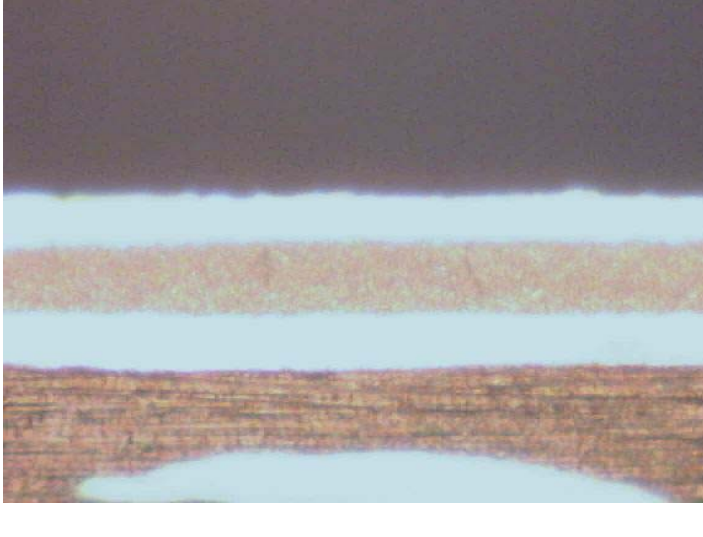
5-I-IV-8

<p>The micrograph was taken at a load of 1264MPa. The micrograph depicts showing 2 microcracks and one half microcrack. The micrographs did not show other kinds of damages before the test was stopped at 1264MPa.</p>
5-I-I-3

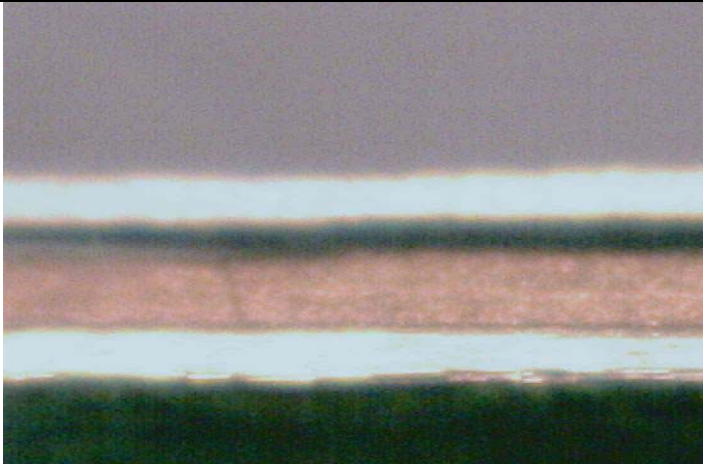
<p>The micrograph was taken at a load of 1264MPa. Delamination was observed at the load of 1026MPa. The test was stopped at 1264MPa.</p>

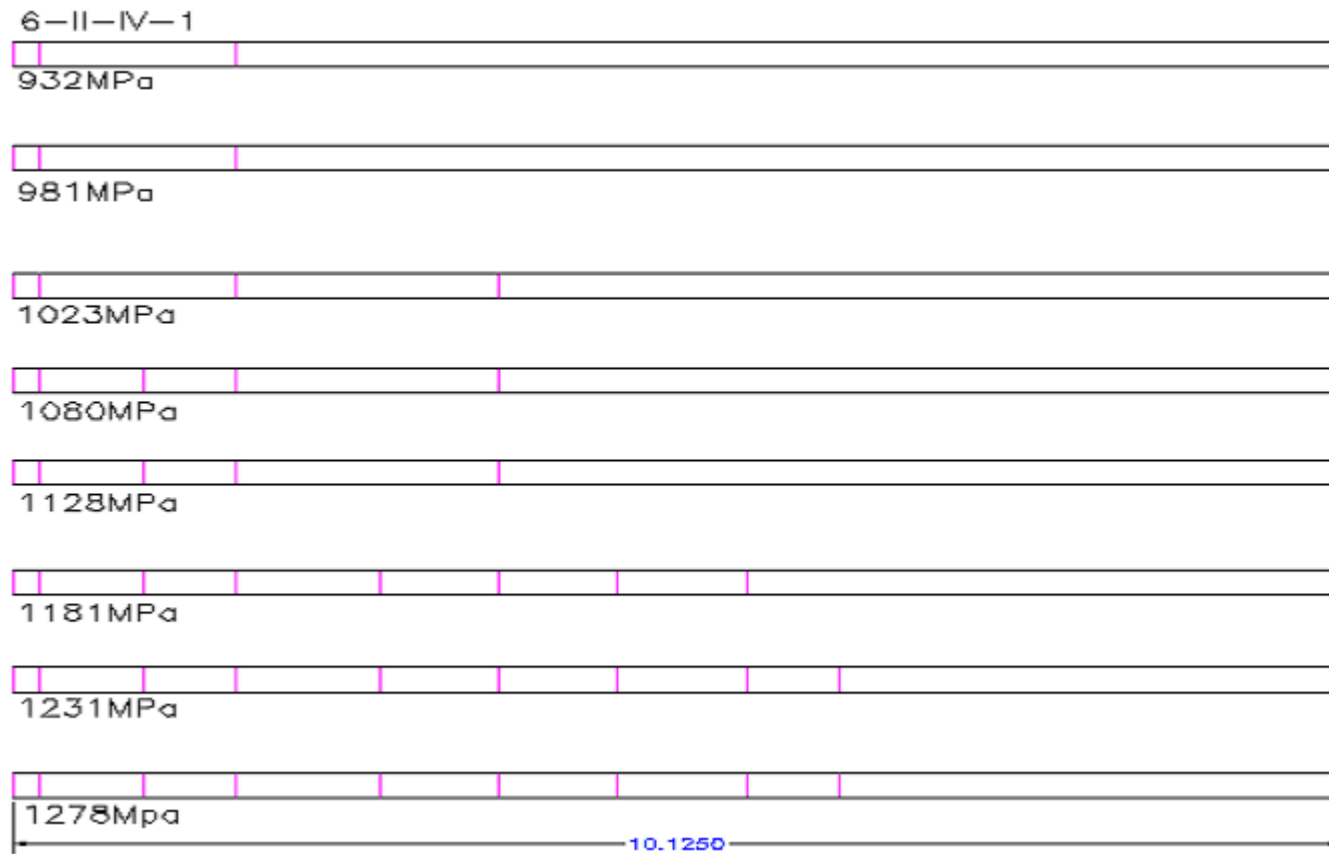
Figure 4.13 Schematics of Crack Propagation in Specimen 6-II-IV-1.

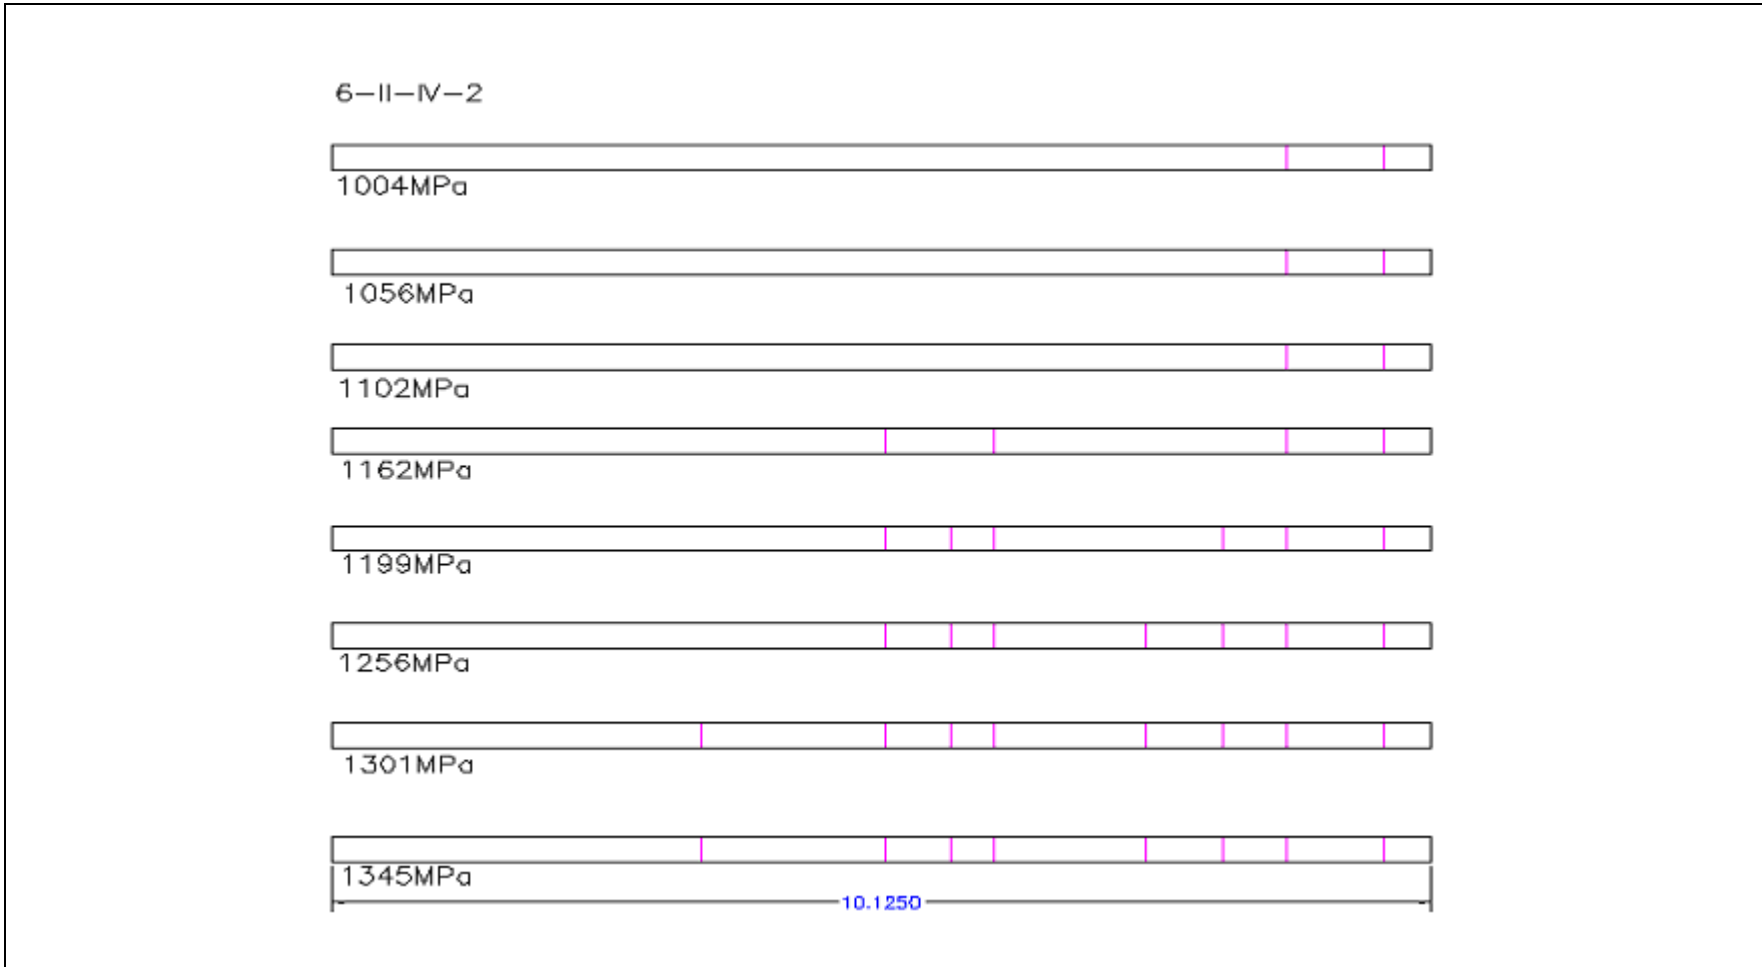
Figure 4.14 Schematics of Crack Propagation in Specimen 6-II-IV-2.

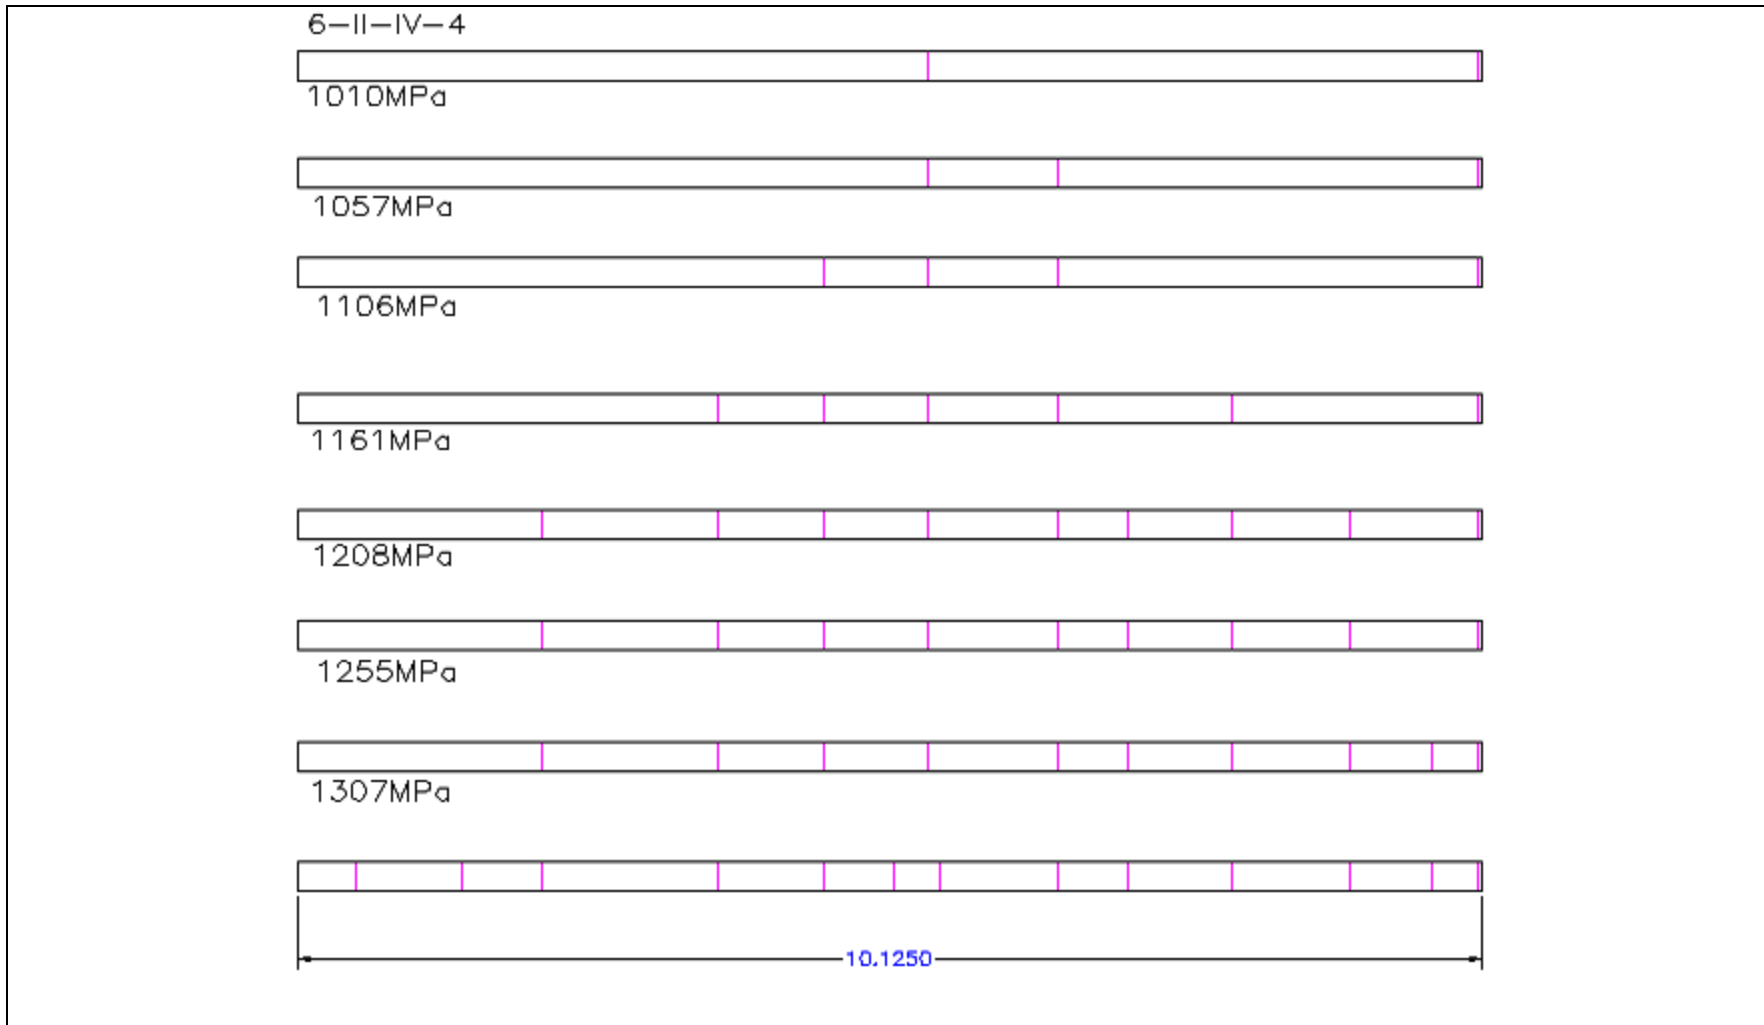
Figure 4.15 Schematics of Crack Propagation in Specimen 6-II-IV-4.

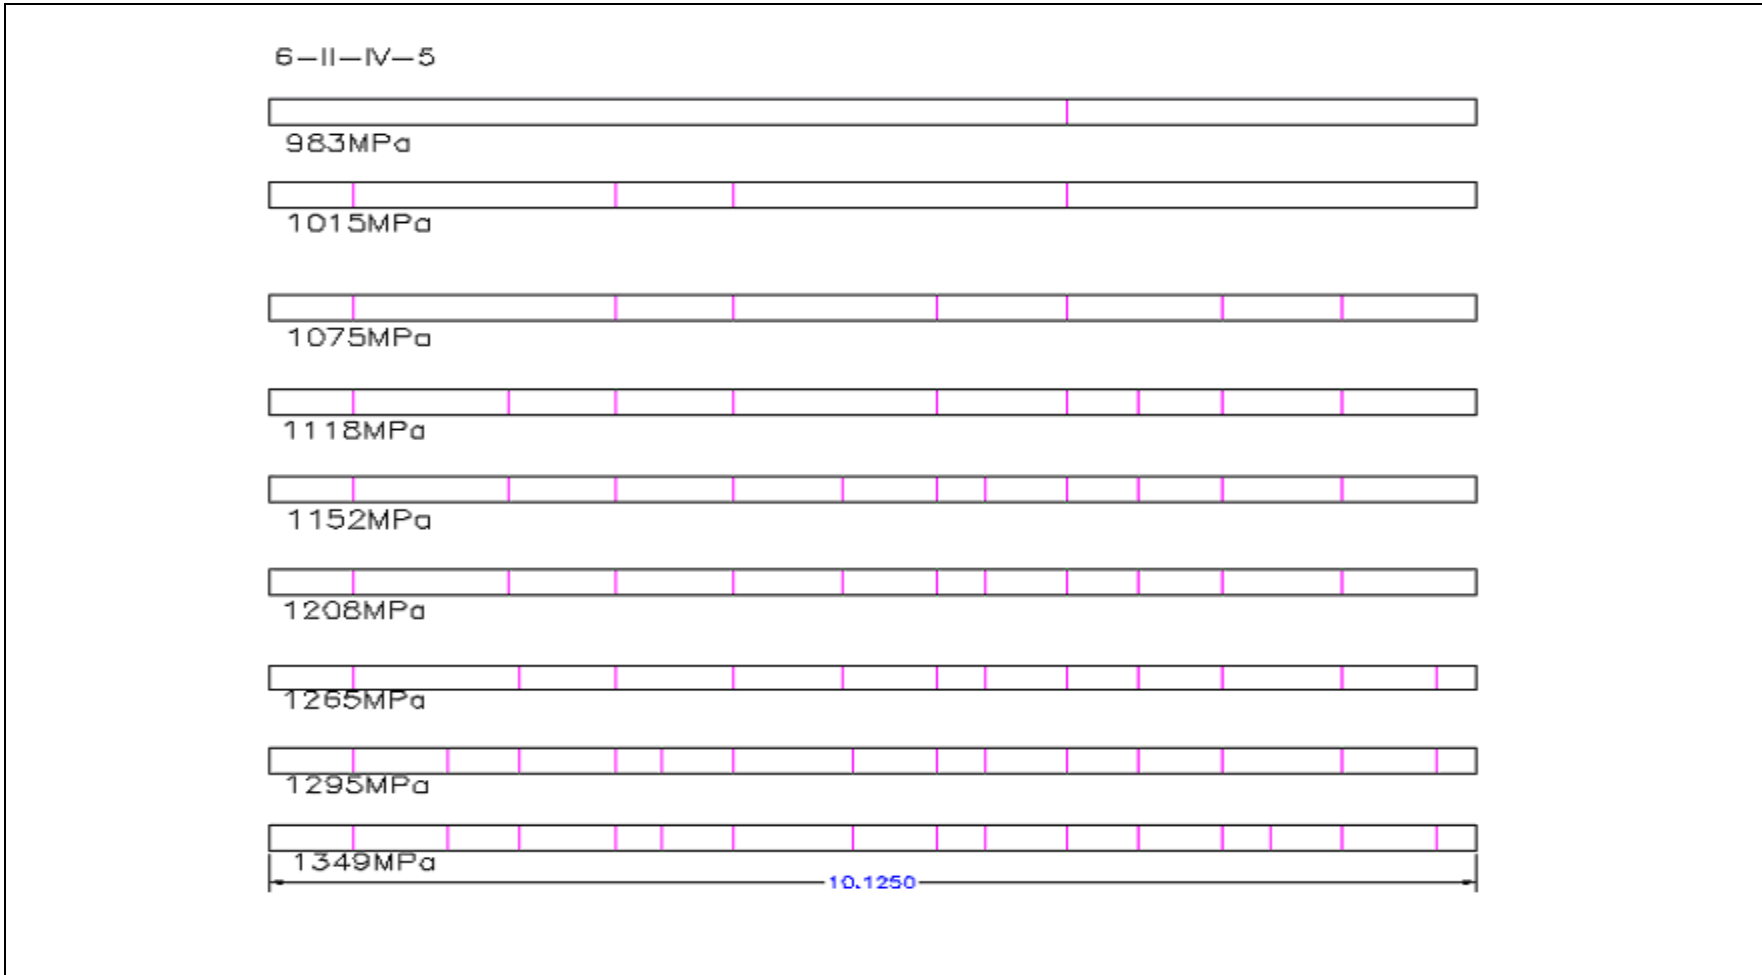
Figure 4.16 Schematics of Crack Propagation in Specimen 6-II-IV-5.

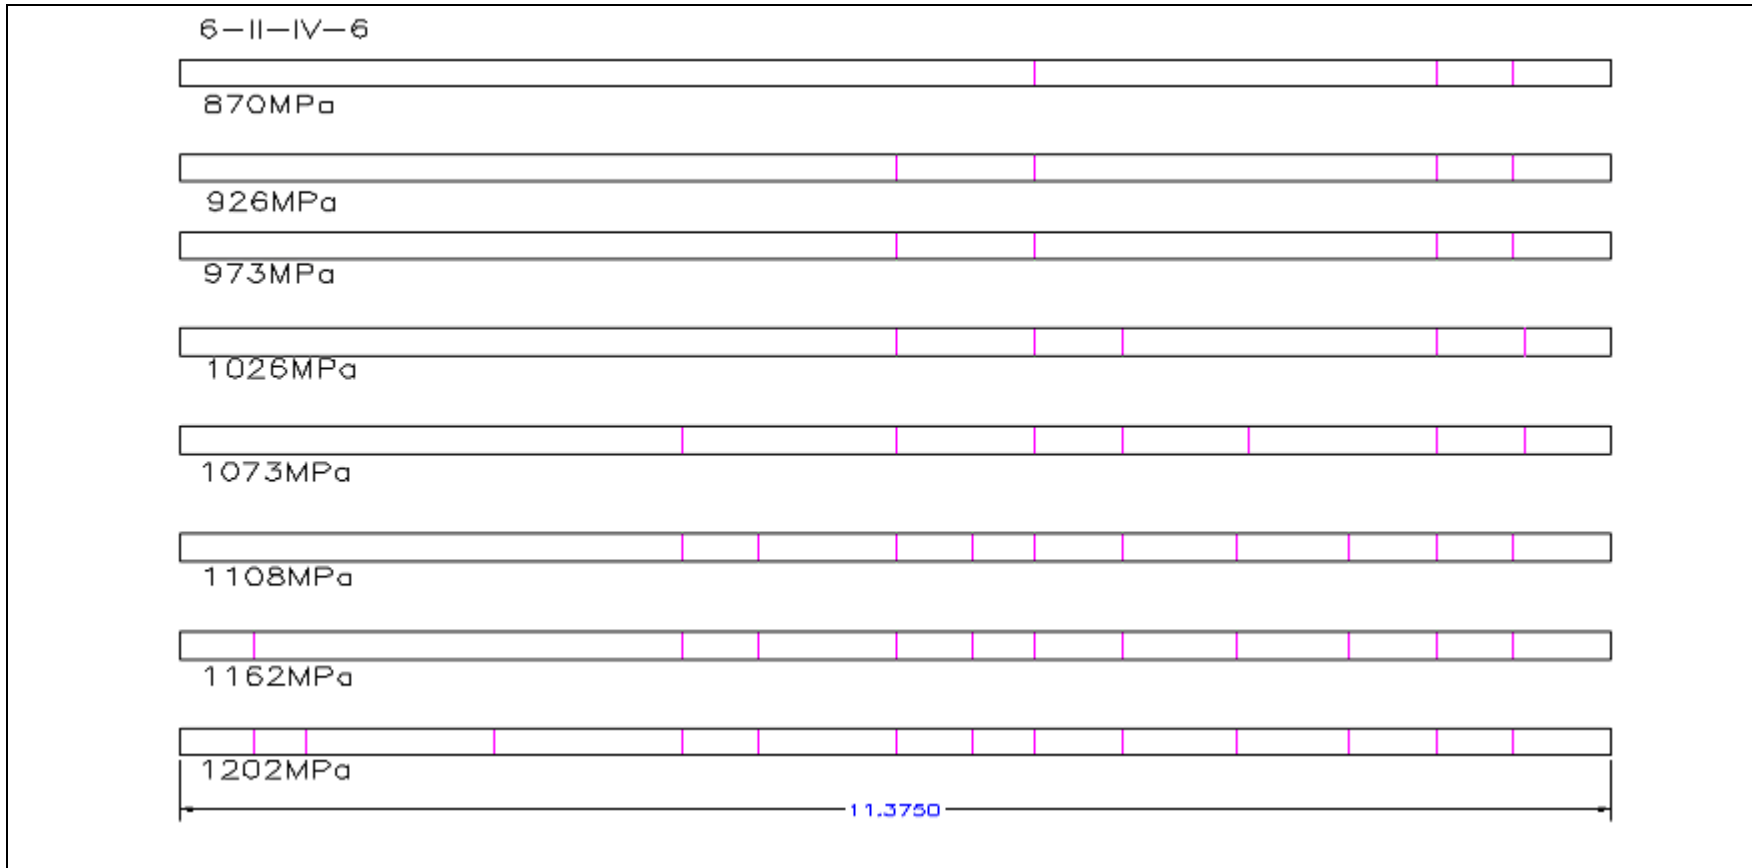
Figure 4.17 Schematics of Crack Propagation in Specimen 6-II-IV-6.

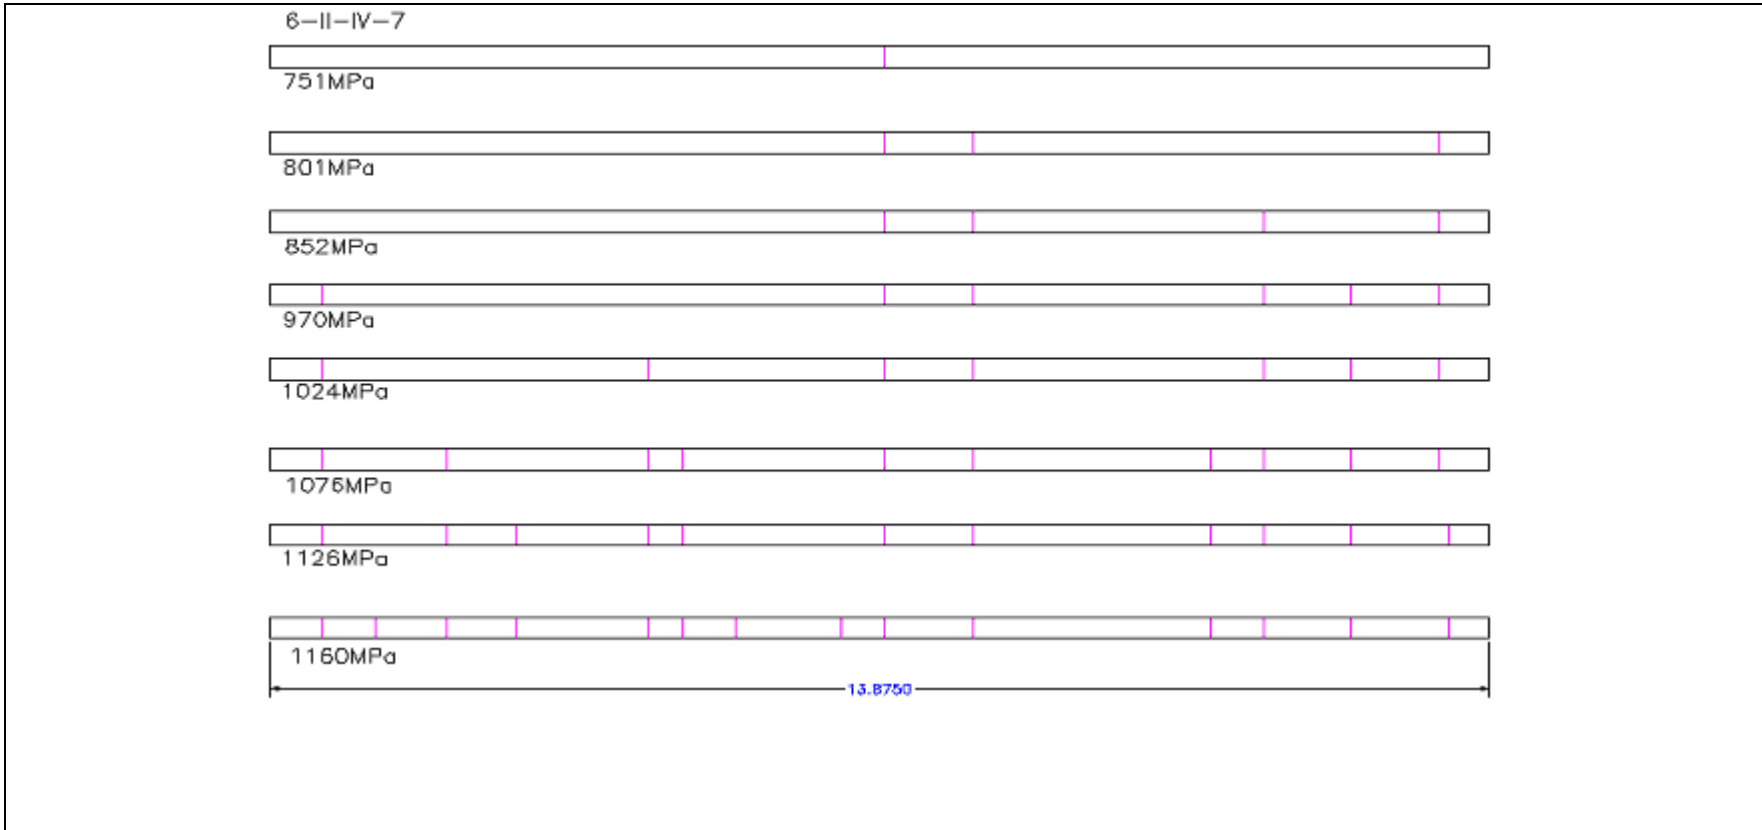
Figure 4.18 Schematics of Crack Propagation in Specimen 6-II-IV-7.

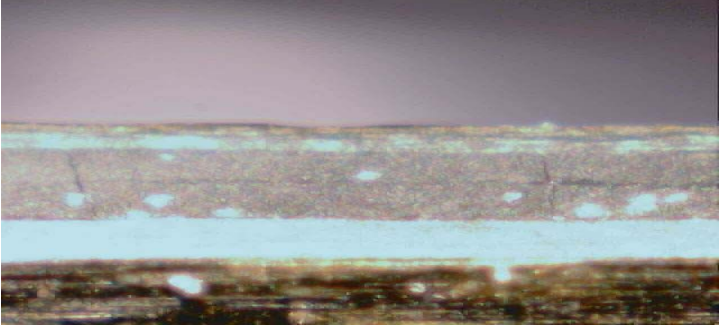
Specimen	Micrograph	Damage Load (MPa) and Discussions
6-II-IV-1

<p>The micrograph in the left is from specimen 6-II-IV-1 at 1262MPa. The specimen did not show other forms of damage other than microcracks and failed near the tabs at 1262MPa.</p>
6-II-IV-2

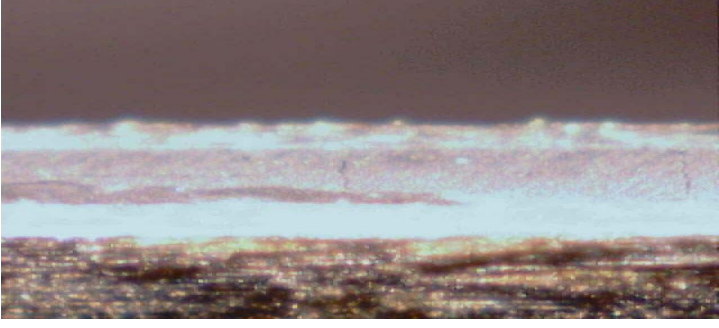
<p>The micrograph in the left is from specimen 6-II-IV-2 at 1256MPa. The specimen did not show other forms of damage other than microcracks and failed into two pieces in the mid span at 1256MPa.</p>

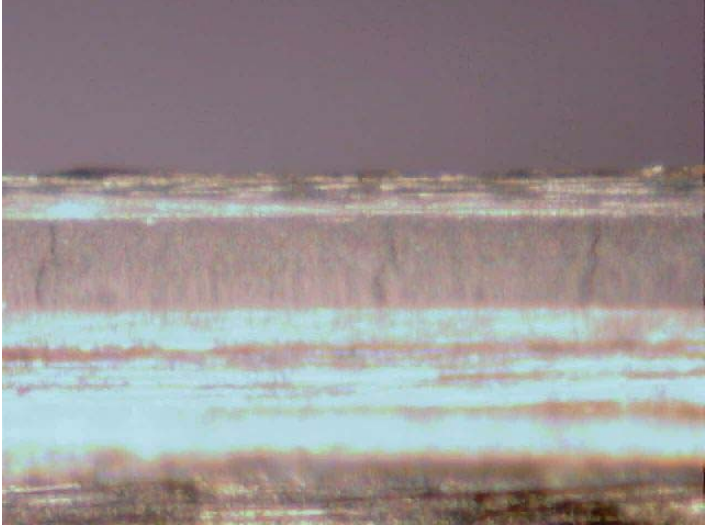
<p>6-II-IV-4</p>

<p>The micrograph in the left is from specimen 6-II-IV-4 at 1358MPa. As seen in the micrograph, the specimen developed fiber pull-out in the 0° plies. The specimen failed at 1381MPa near the tabs.</p>
<p>6-II-IV-5</p>

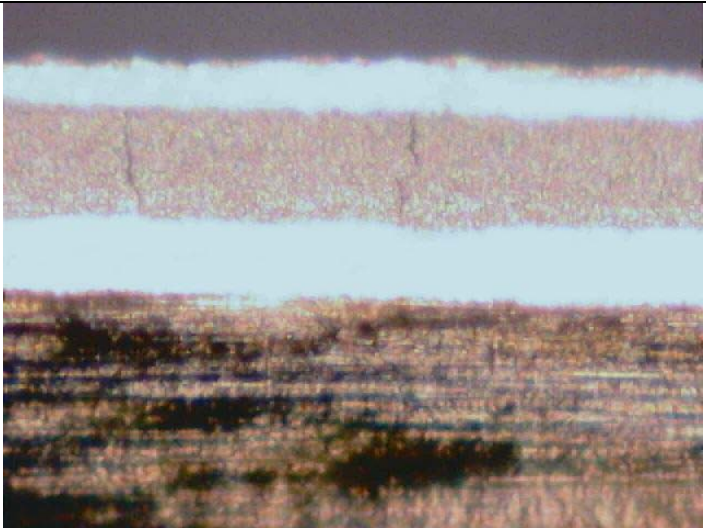
<p>The micrograph in the left is from specimen 6-II-IV-5 at 1295MPa. The specimen did not show any damage other than microcracks and failed near the tabs at 1349MPa.</p>

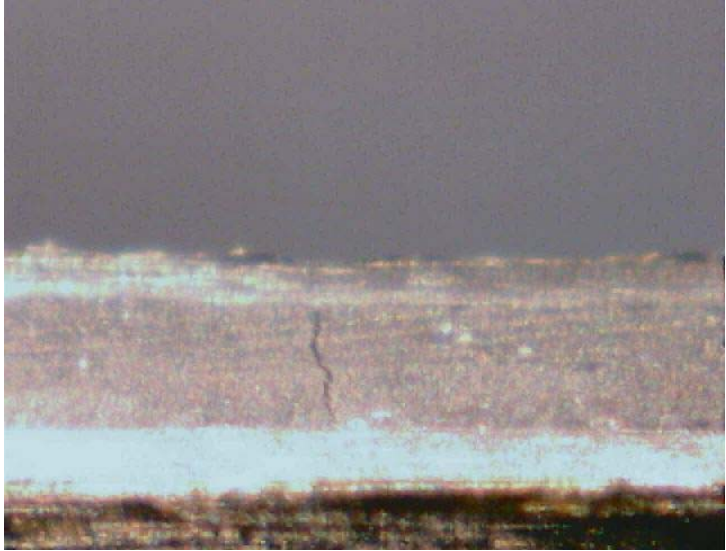
<p>6-II-IV-6</p>

<p>The micrograph in the left is from specimen 6-II-IV-6 at 1202MPa. The specimen did not show any damage other than microcracks and failed near the tabs at 1202MPa.</p>
<p>6-II-IV-7</p>

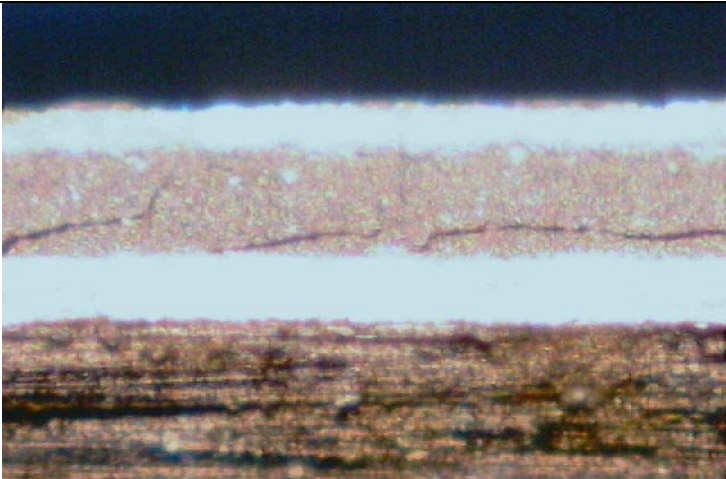
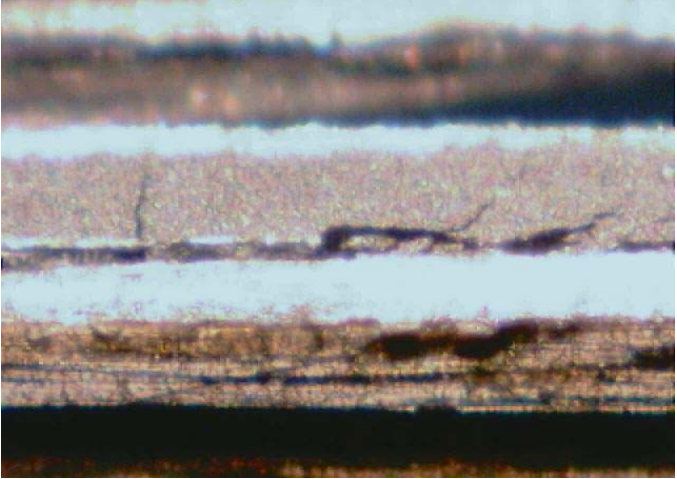
<p>The micrograph in the left is from the specimen 6-II-I-7 at the load of 1160MPa. As seen in the micrograph, the specimen did not delaminate at this location and a longitudinal in the 90° was seen. This crack initiated at a location left of this micrograph and is shown in the next micrograph. The specimen failed immediately into two pieces at 1160MPa. At this location fiber pull-out is seen.</p>

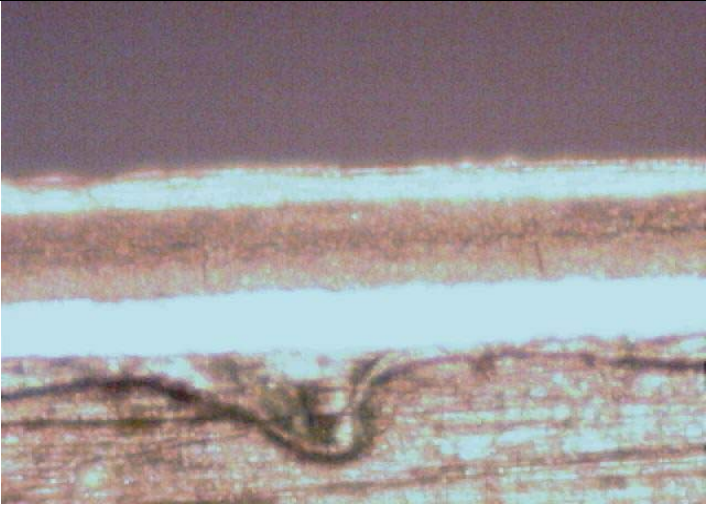
6-II-IV-3

<p>The micrograph in the left is from specimen 6-II-IV-1 at 1310MPa. The specimen did not show any damage other than microcracks and failed under the tabs at 1357MPa.</p>

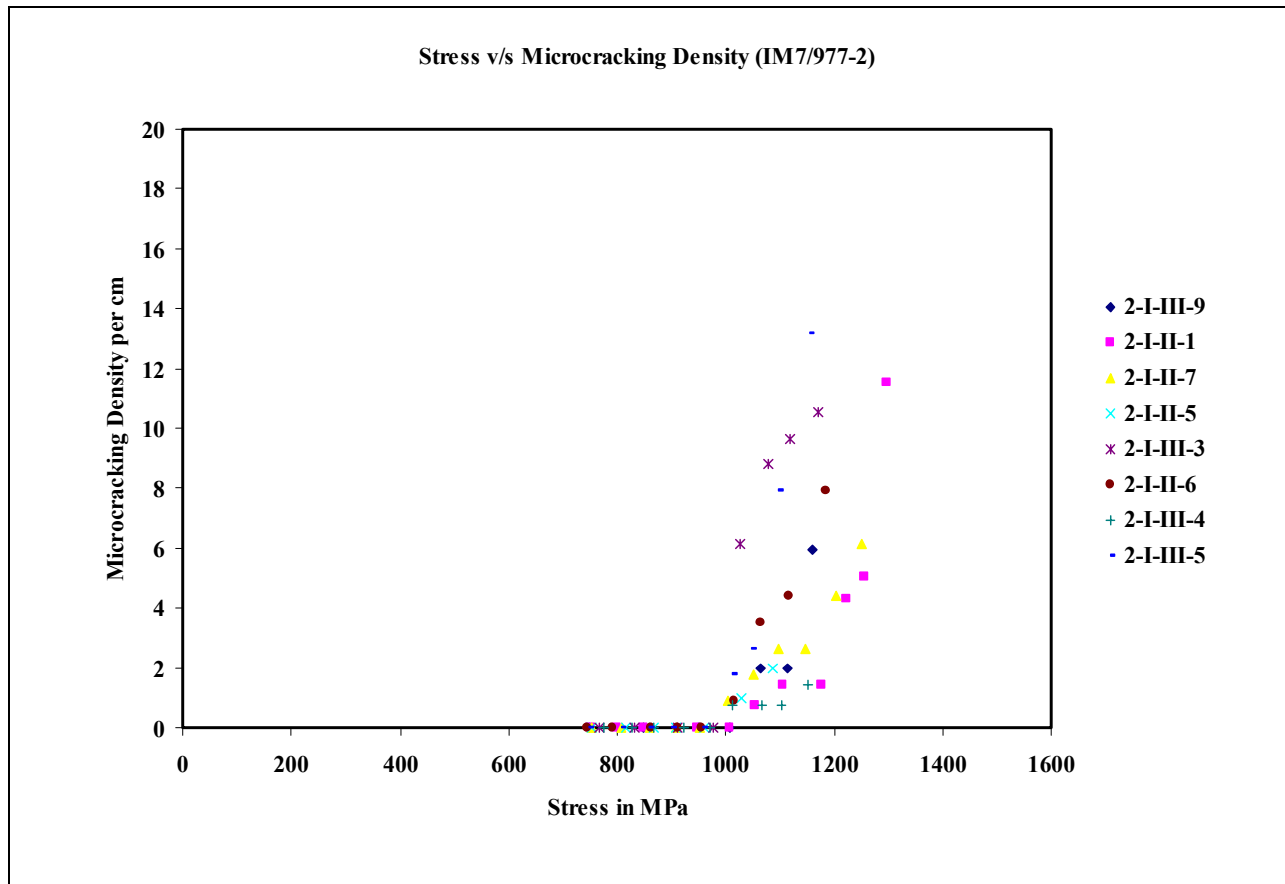
Figure 4.19 Plot of Microcracking Density versus Applied Stress for Material System IM7/977-2.

A plot of microcracking density and applied load was plotted for all the specimens from all three material systems. Figures 4.19, 4.20 and 4.21 display the plot of microcracking density (cracks/cm) and applied stress (MPa).

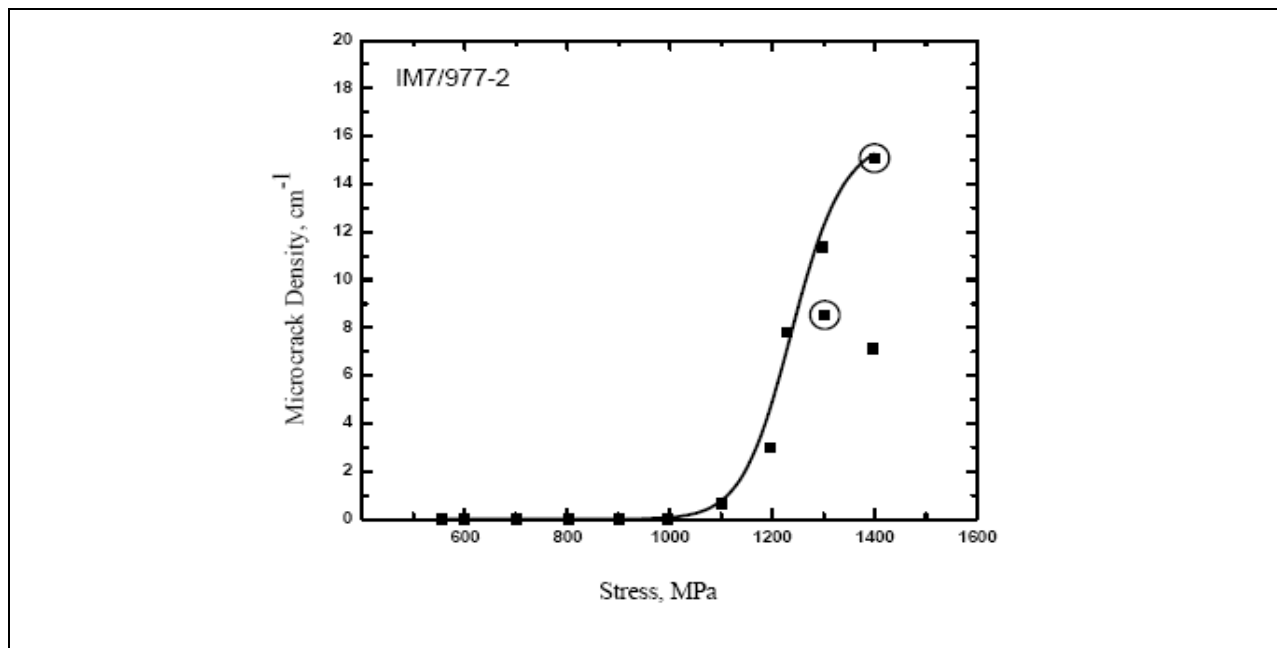
Figure 4.20 Plot of Microcracking Density versus Applied Stress for Material System IM7/977-2 from Ref [1].

Figure 4.20 is the plot of microcracking density as a function of applied stress for material system IM7/977-2 from the preliminary studies [1]. It can be seen that the material system shows the steep increase in crack density after the initiation of microcracks.

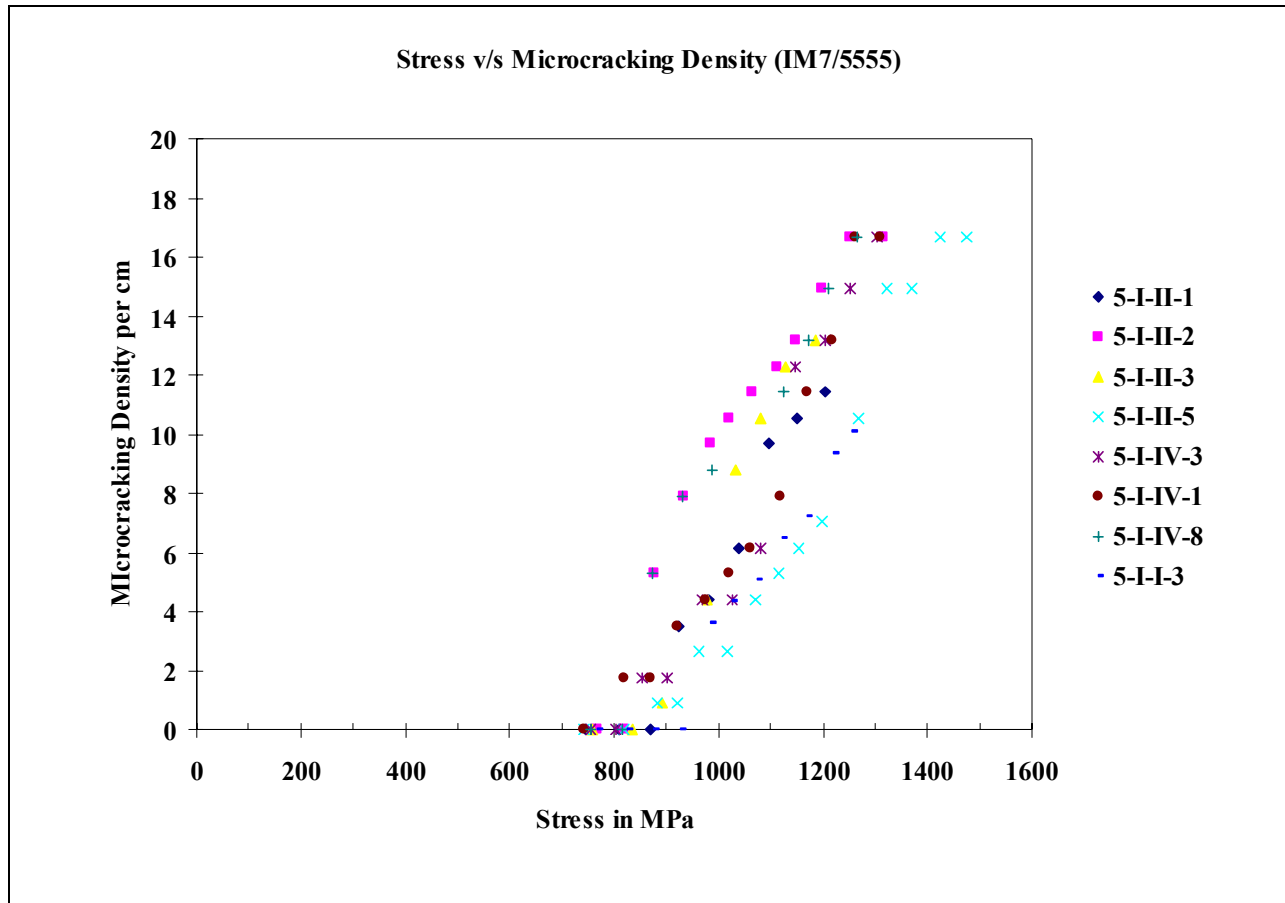
Figure 4.21 Plot of Microcracking Density versus Applied Stress for Material System IM7/5555.

From Figure 4.21 it can be seen that microcracks started forming in the range of 800MPa to 900MPa for material system IM7/5555. After the formation of the initial microcracks the increase in number of microcracks as a function of applied stress is not as steep as for material system IM7/977-2. The formation of microcracks is more gradual. Four of the six specimens tested to failure reached same crack density of 16.7cracks/cm before failure. Another observation is that the crack density remained the same for three of the specimens as the load was increased. From this, it can be concluded that the crack saturation density for the IM7/5555 material system is around 17cracks/cm.

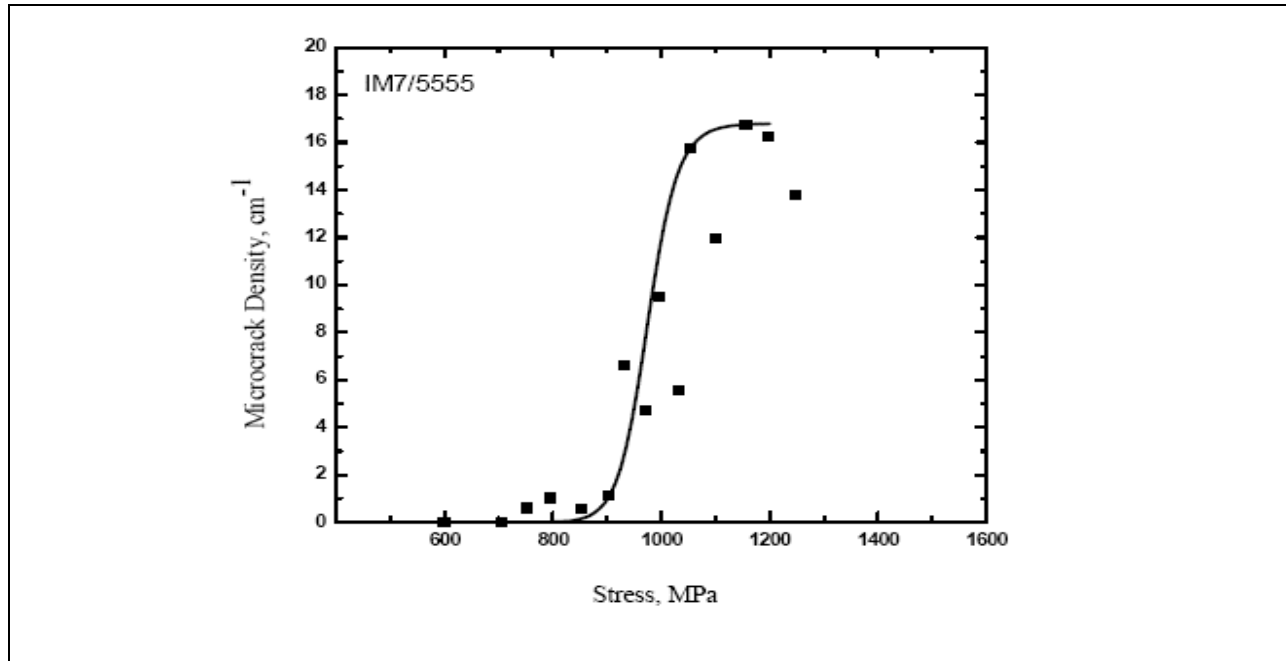
Figure 4.22 Plot of Microcracking Density versus Applied Stress for Material System IM7/5555 from Ref [1].

In addition, the charts obtained in both the current study and the preliminary study both suggest that the material system reaches a crack saturation density of approximately 17 cracks/cm.
