Investigation of Microcracking and Damage Propagation in Cross-Ply Composite Laminates

INVESTIGATION OF MICROCRACKING AND DAMAGE PROPAGATION IN CROSS-
PLY COMPOSITE LAMINATES

A Thesis

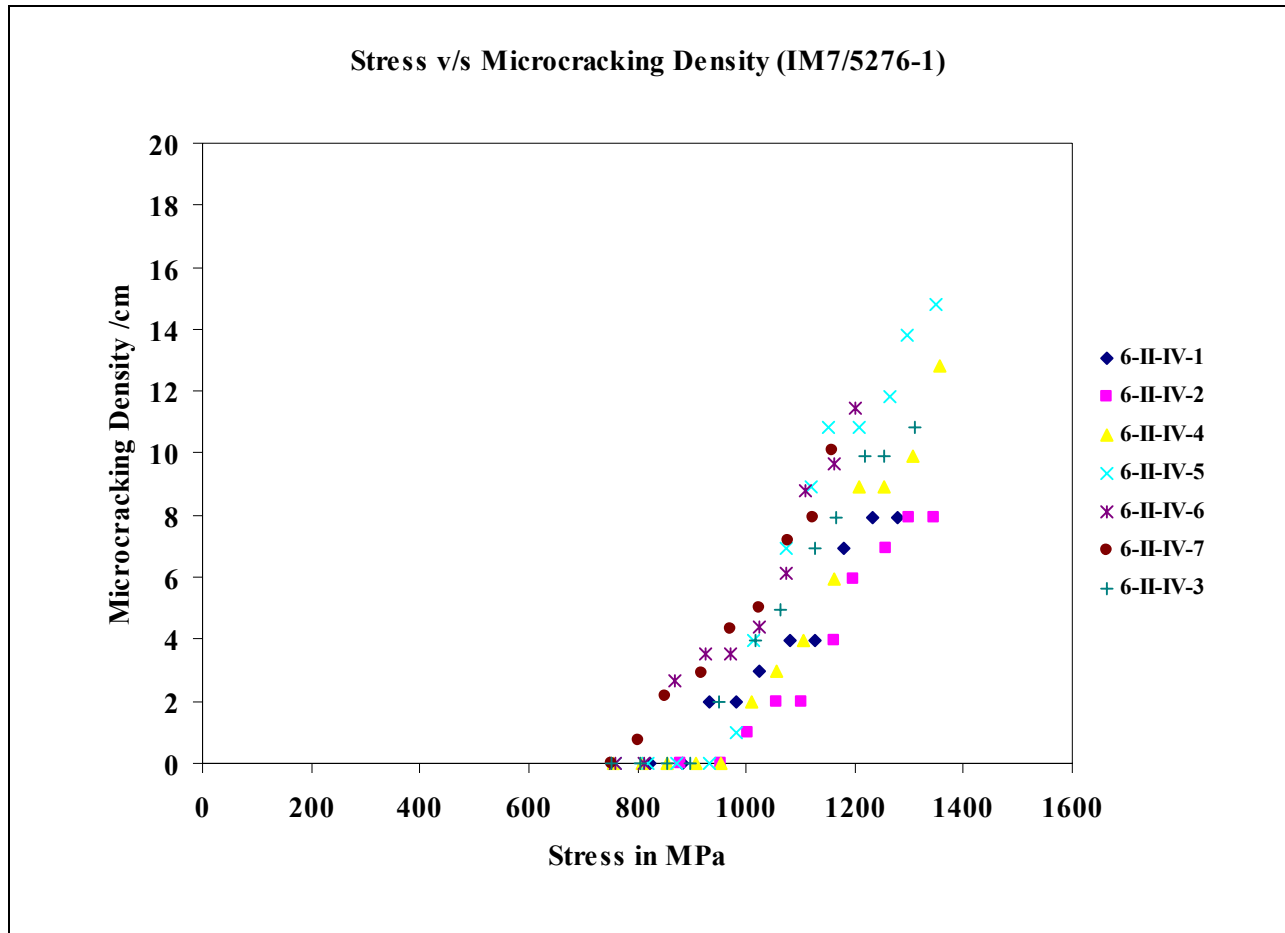
Figure 4.23 Plot of Microcracking Density versus Applied Stress for Material System IM7/5276-1.

A plot of number of microcracks formed per centimeter as a function of applied stress is shown in the Figure 4.23 for material system IM7/5276-1. The starting stress for microcracking was more scattered and they started to microcrack between loads of 750 MPa and 950 MPa. There is no immediate increase in the number of microcracks after formation of the initial cracks and the slope of the function is not as steep as the slope of the IM7/977-2, and even the IM7/5555, data. It can also be noted that after the onset of microcracking the specimens failed at an additional average load of 340MPa, showing a dependence of initiation load to failure load. The average crack density for all seven specimens was around 11 cracks/cm. Specimen 6-II-IV-5 had the maximum number of microcracks with a microcracking density of 14.8cracks/cm.

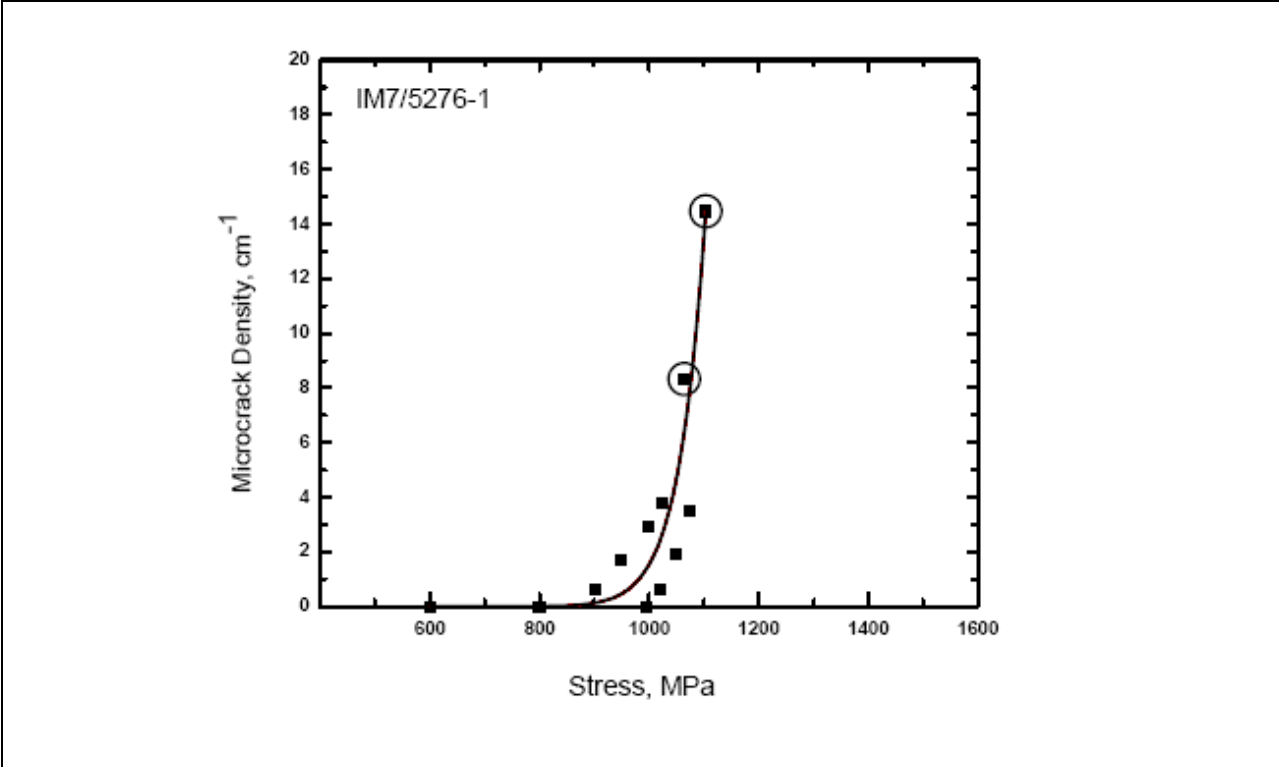
Figure 4.24 Plot of Microcracking Density versus Applied Stress for Material System IM7/5276-1 from Ref [1].

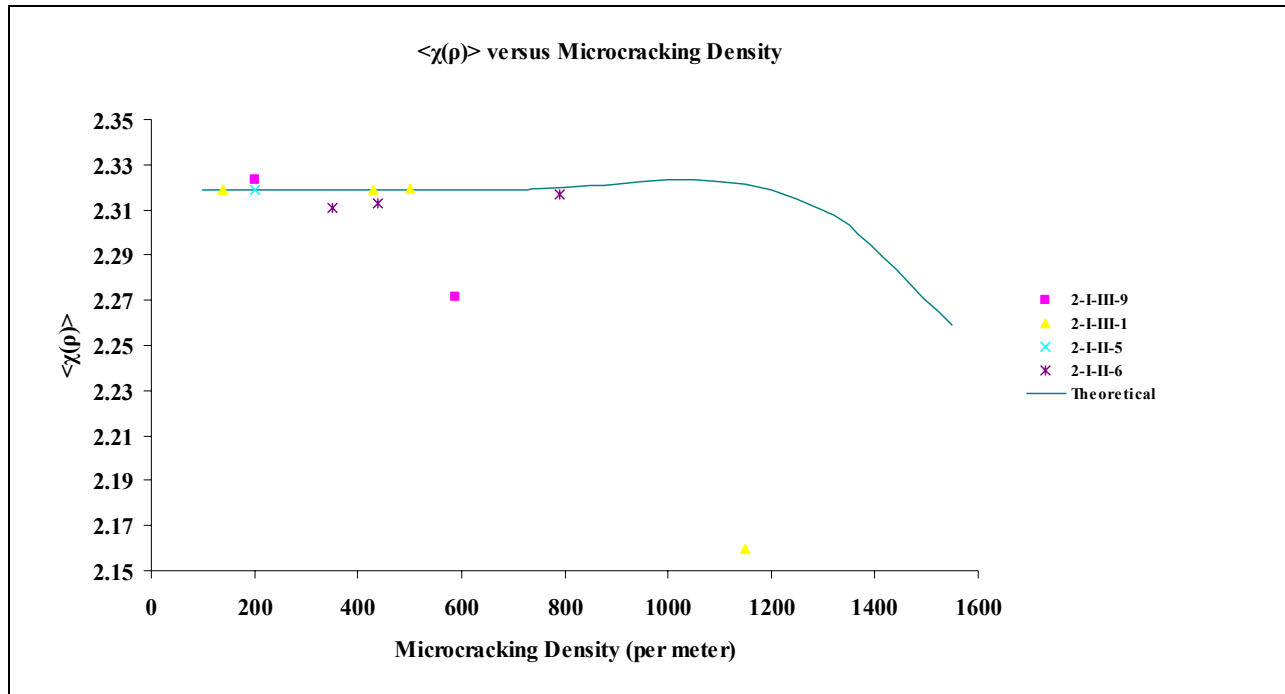
Figure 4.25 Plot of $\langle \chi(\rho) \rangle$ as a function of Crack Density.
