A Comparison Of Installation Methods And Maintenance Practices Of Protected Side Armoring

A Comparison Of Installation Methods And Maintenance Practices Of Protected
Side Armoring

Master of Science
in
The Department of Civil Engineering

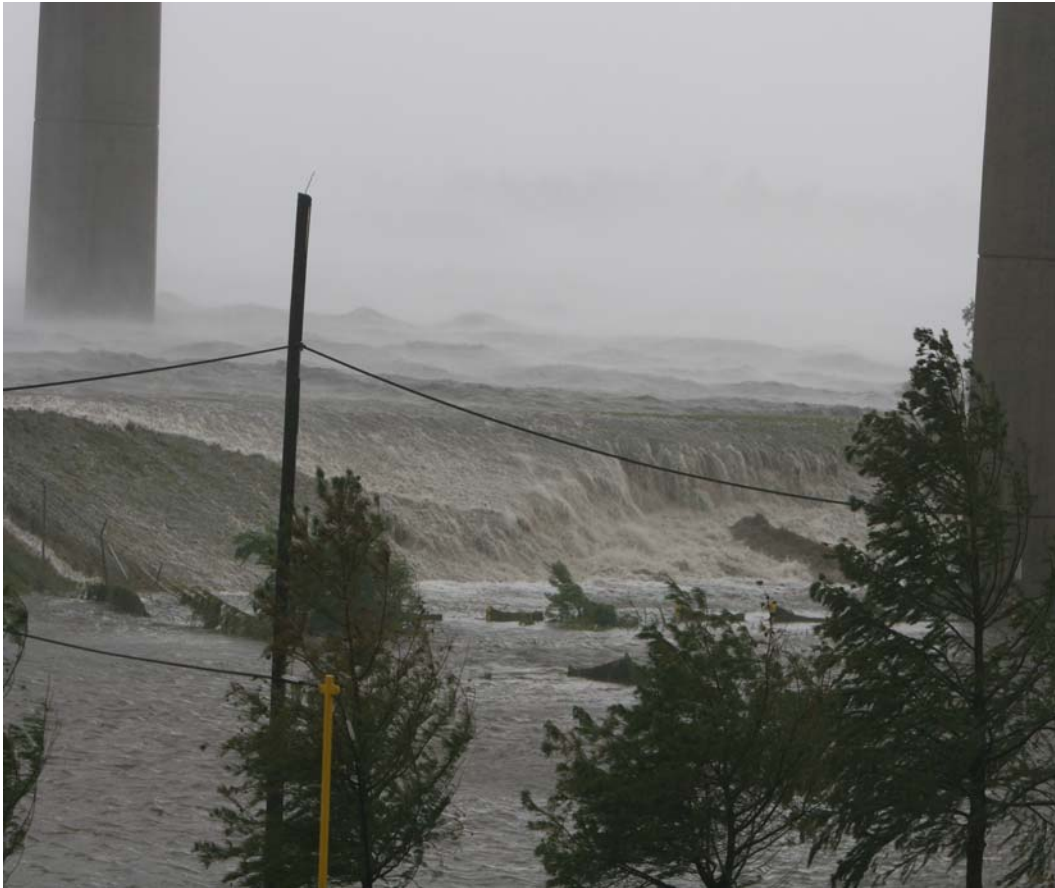
Photo 1: This photo was taken during Hurricane Katrina in New Orleans East at the Paris Rd. Bridge

The conditions shown in Photo 1 caused scouring to the protected side on the earthen levees and the hardened (concrete/sheetpile) floodwalls. In some areas the scouring was extensive and breaches to the system occurred. Photos 2 show's the effects of the storm surge that was captured in Photo 1.

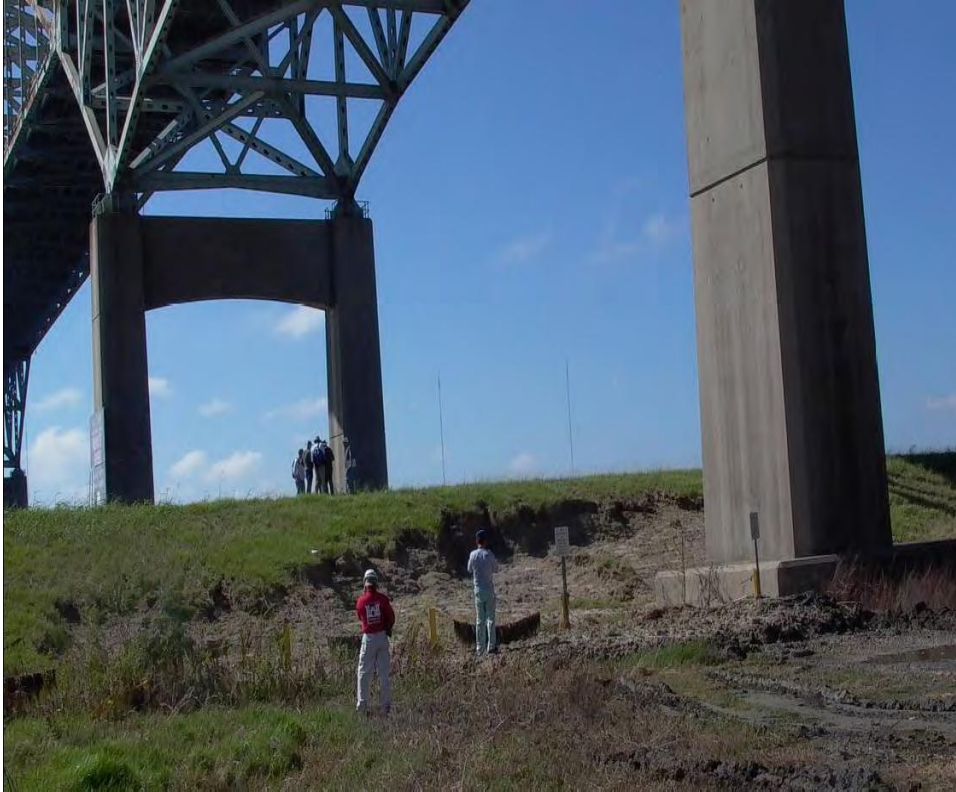
Photo 2: This photo is of the same location in photo #1 showing the damages that were incurred. Scouring around the bridge supports was extensive.

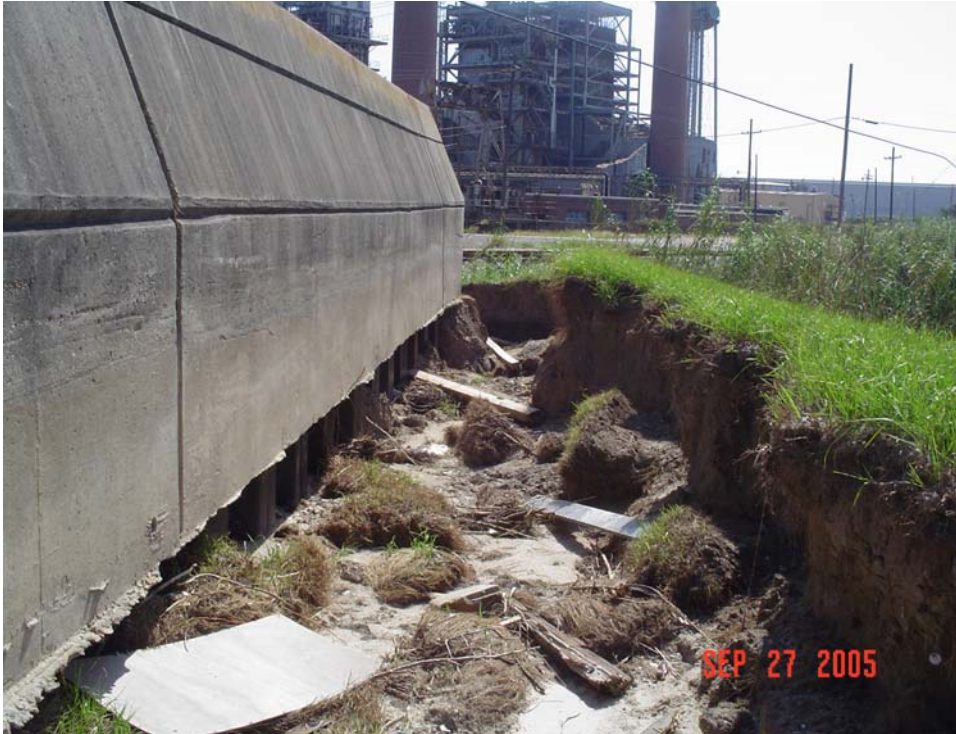
Photo 3: The damages to the floodwalls on the protected side when wave overtopping occurred is shown in this photo.

Photo 3 shows the damages that occurred to the protected side on floodwalls. One can see the sheetpile under the floodwall which indicates a scour hole about 5 feet deep. Unlike the earthen levees, which are sloped and therefore the free flow overtopping just ran its course down the slope, the floodwalls height creates a downpour of water that remains on the face of the floodwall whereby creating a concentrated scouring effect at the base of the floodwall stem. On average, the depth of scour on the protected side of the floodwalls that were overtopped ranged from 2-8 feet. This is a very large reduction in the levee/floodwall section that is used in the design to resist the water load to top of

the wall. The design does not consider any loss of section due to overtopping and scouring.

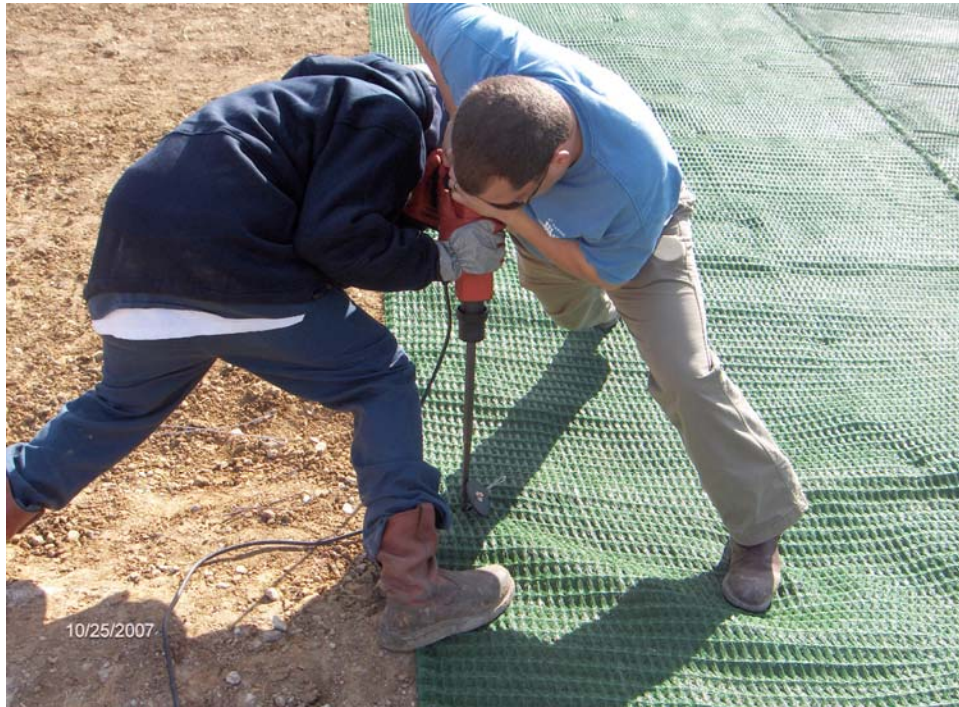
Photo 7: Manual drilling of the anchors.

(5) drill bits were broken, 2 using the excavator and 3 using the hand held drill. The mat itself is very durable and easy to work with. It keeps its form and structure & provides a workable surface with surface traction for workers to maneuver. Its woven construction is very tight and there are concerns with this products ability to allow grass growth in-between the woven fabric. Anchor installation stopped due to broken bits with no more in reserve. The work was nearly a third complete and took 4 hours.

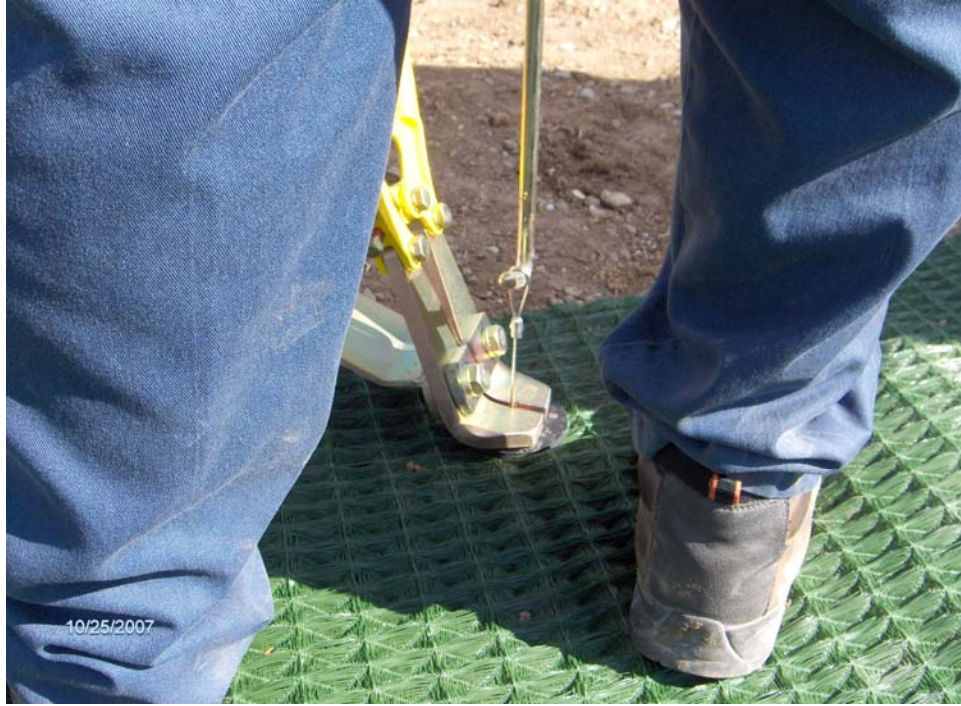
Photo 8: Anchor cable is pulled in tension and crimp.

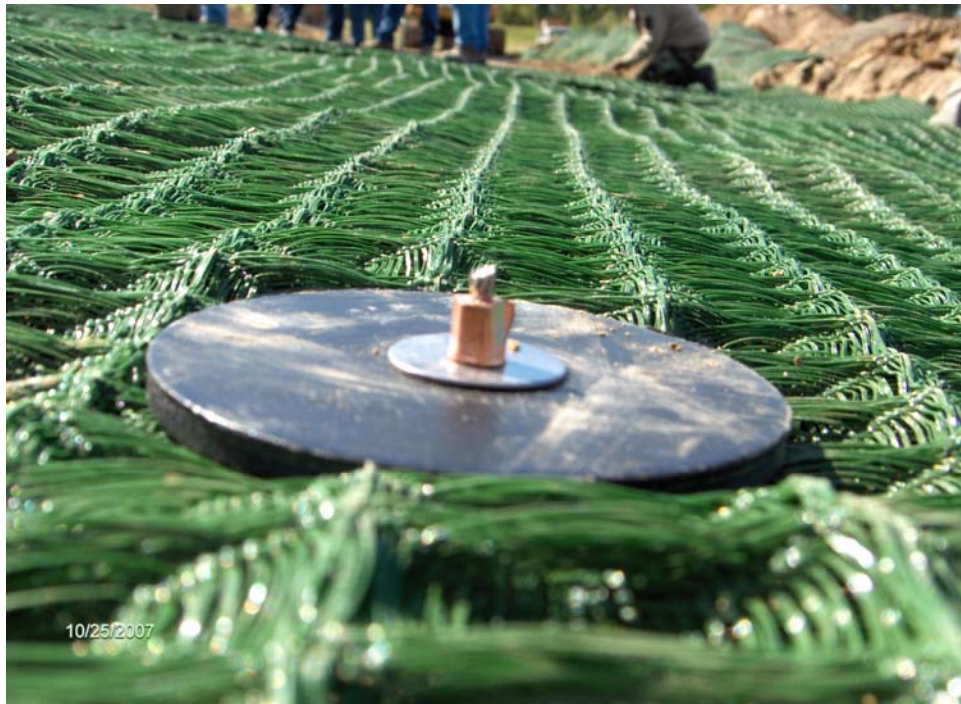
Photo 9: Excess anchor cable is cut to eliminate stickup.

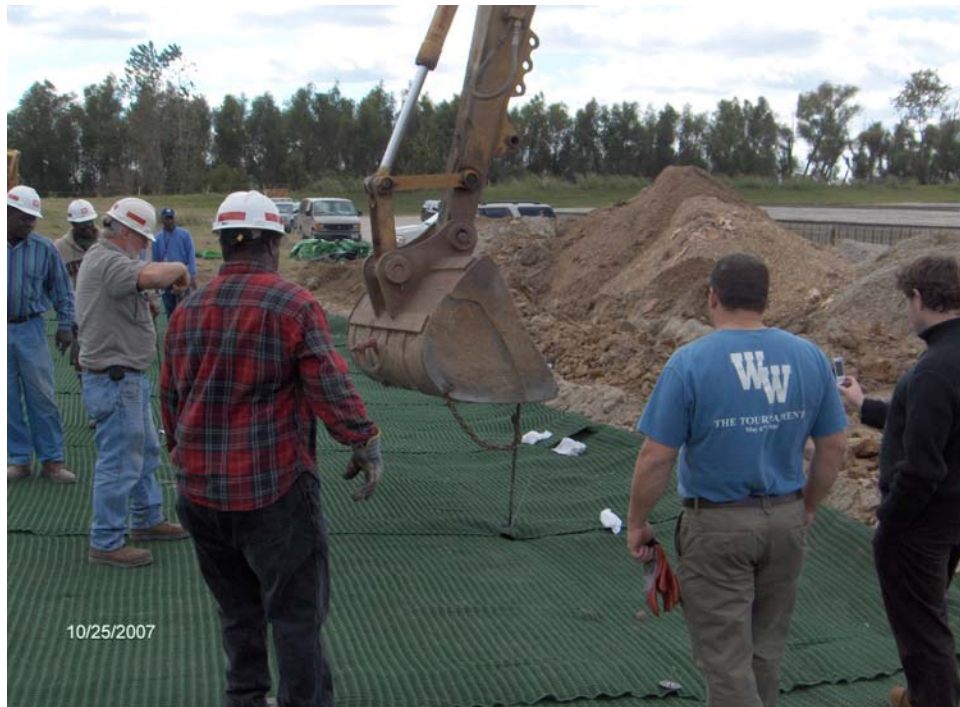
Photo 10: Due to manual anchor drilling being problematic, the drill bit is welded to the excavator bucket and the anchors are mechanically installed.

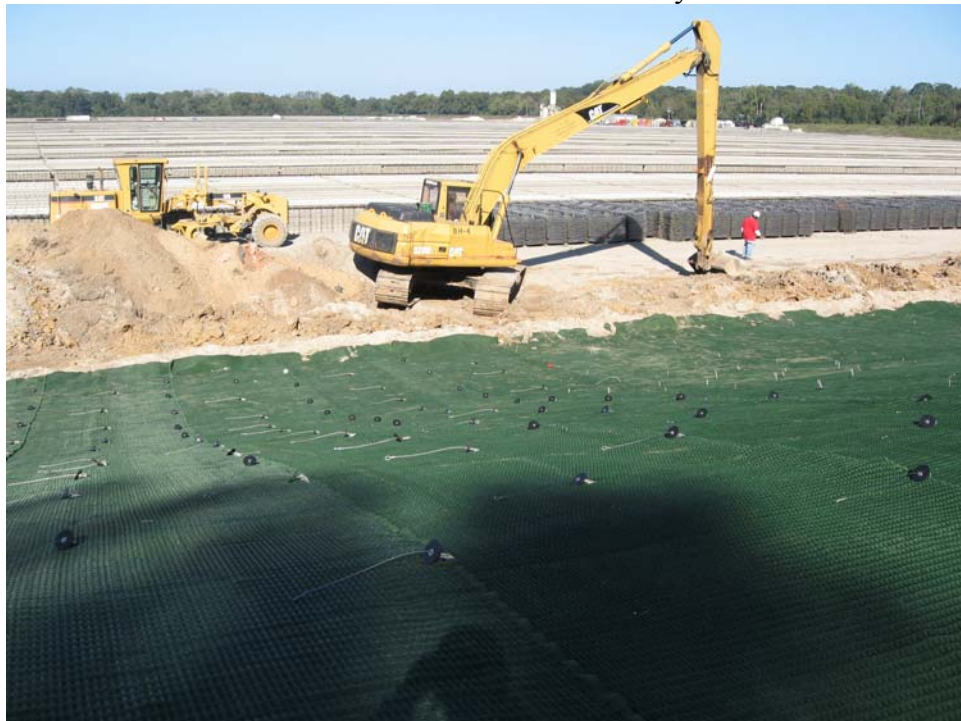
Photo 11: The ARVS is rolled out and anchors are spaced for placement.

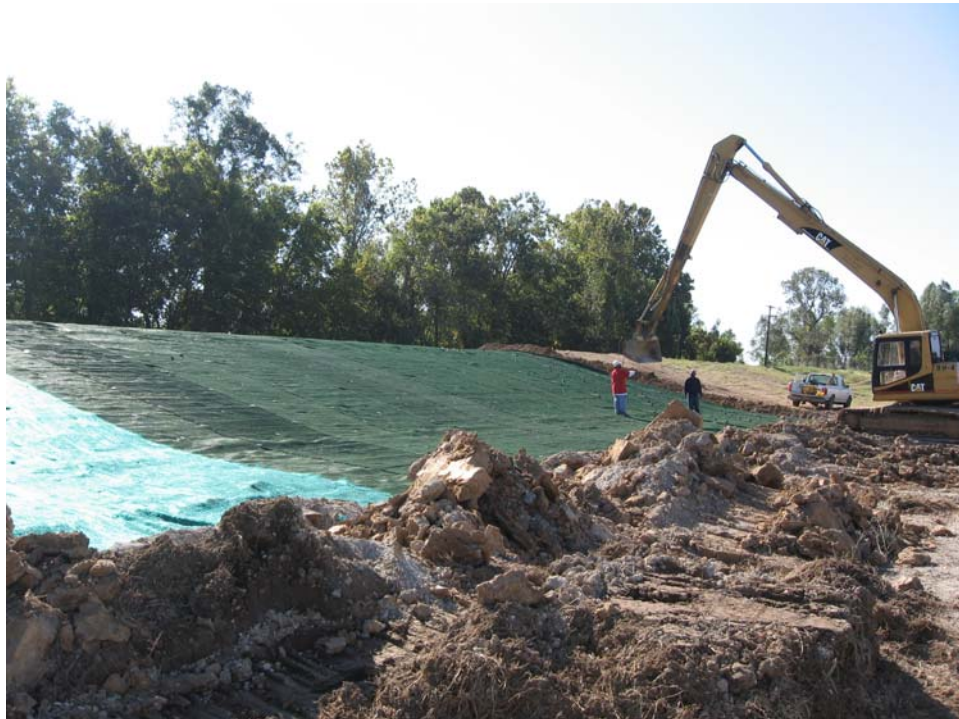
Photo 12: Overview of the ARVS installed and the Western Excelsior mats start of roll out.

Western Excelsior mesh was installed in the trench, the trench was backfilled and the mesh was rolled out using the same process and steps that were used during the Anchored Reinforced Vegetation System (ARVS) installation. The staples are still installed as the pervious product, but the only difference is that this system does not use anchors in its installation. This product is not as tightly woven as the ARVS. This product has a lesser strength than the previous. It took three (3) hours to completely install this product.

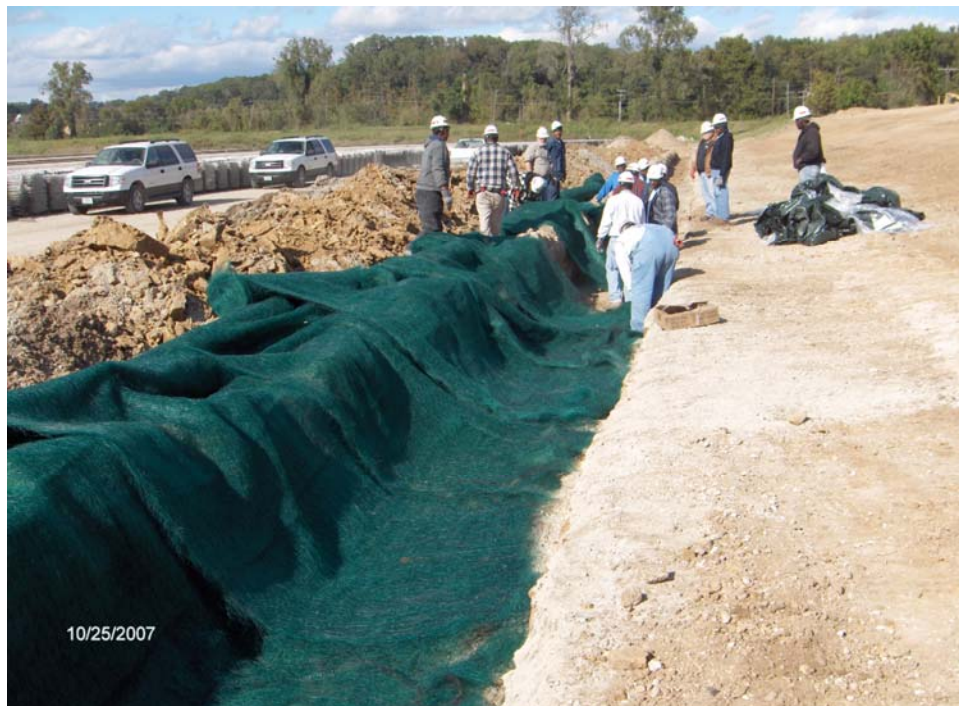
Photo 13: Western Excelsior mats placed in trench in the same fashion as the ARVS.

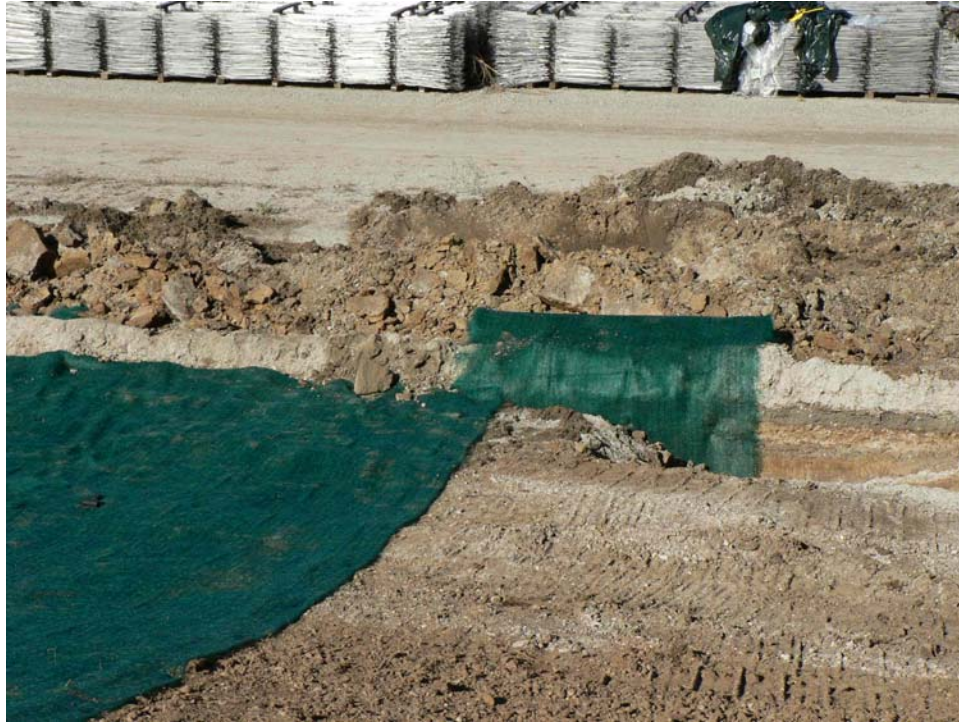
Photo 14: The trench is backfilled and the mat is rolled over the trench creating an anchor.

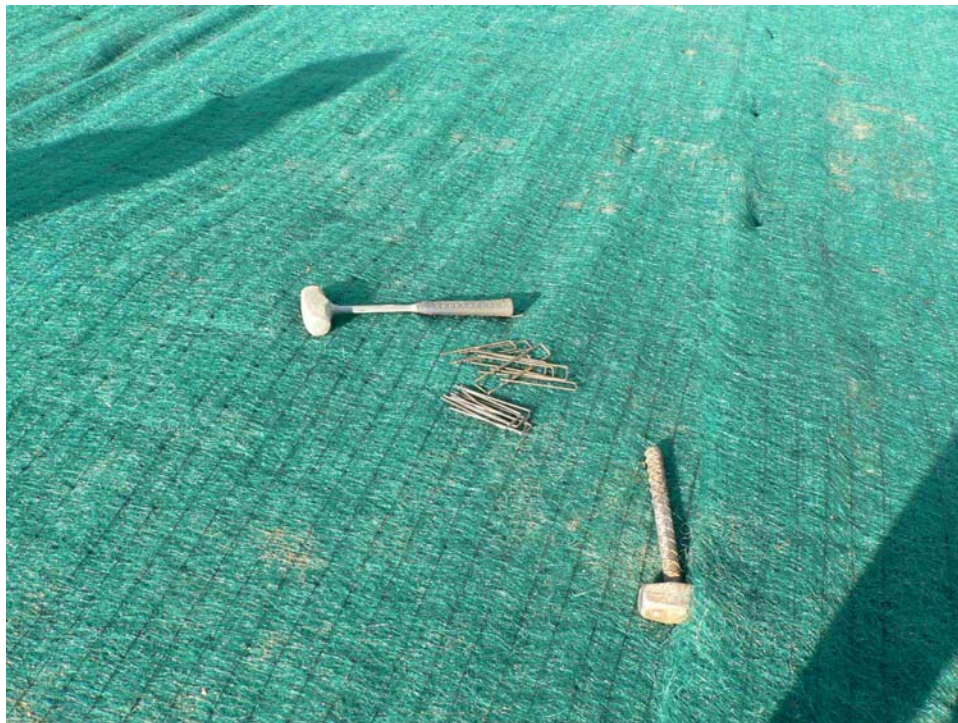
Photo 15: Only tools needed are this installation are staples and a hammer.

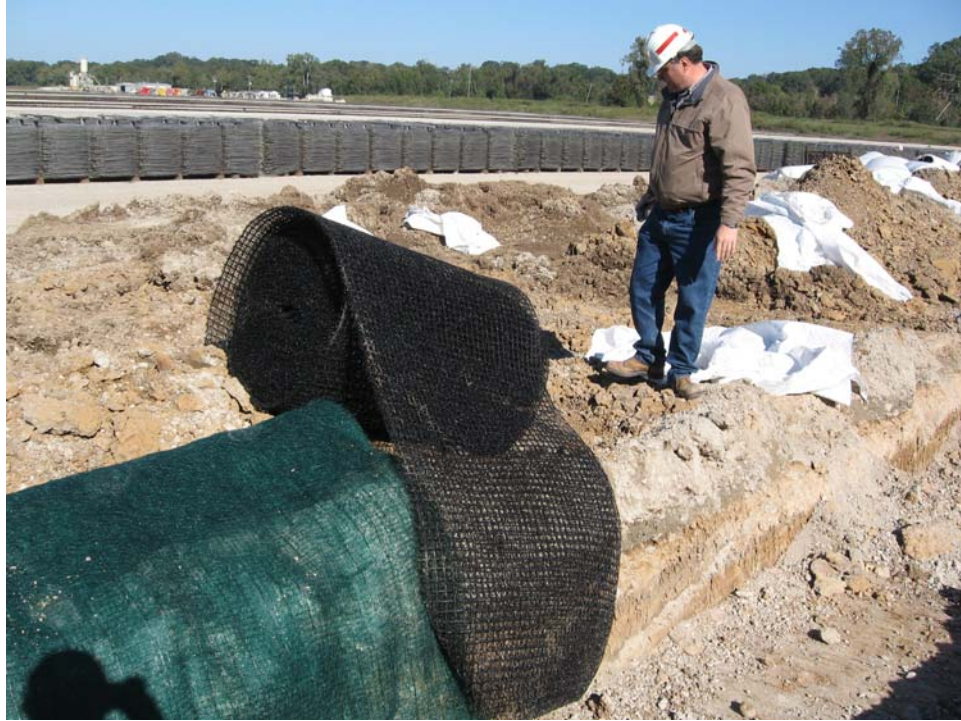
Photo 18: Start of Enkamat product installation.

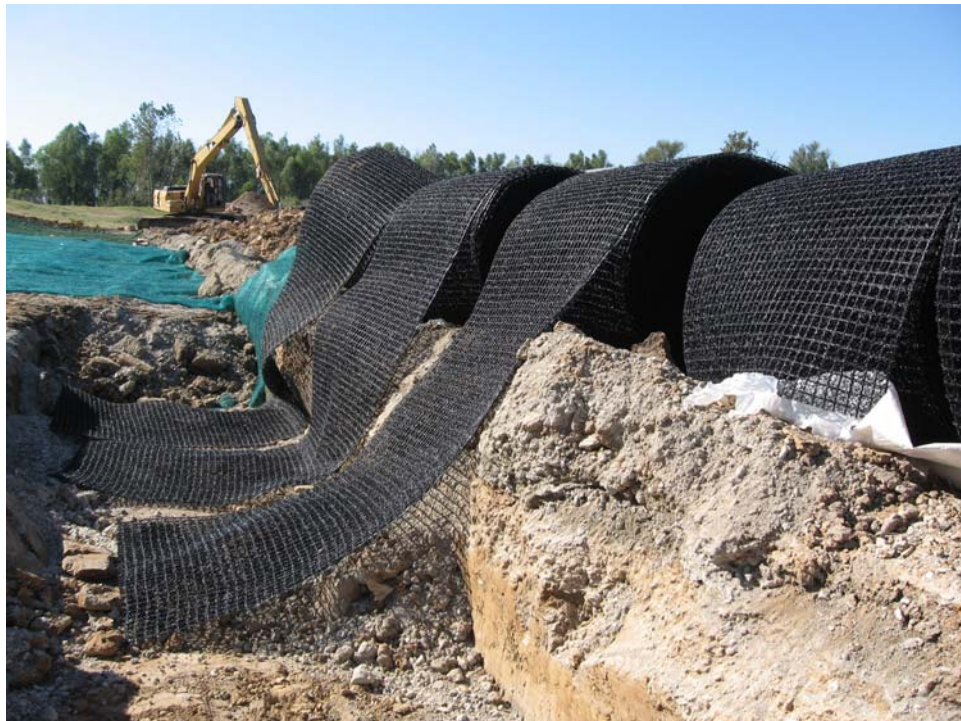
Photo 19: The Enkamat S is being placed in the trench as the two previous geosynthetics.

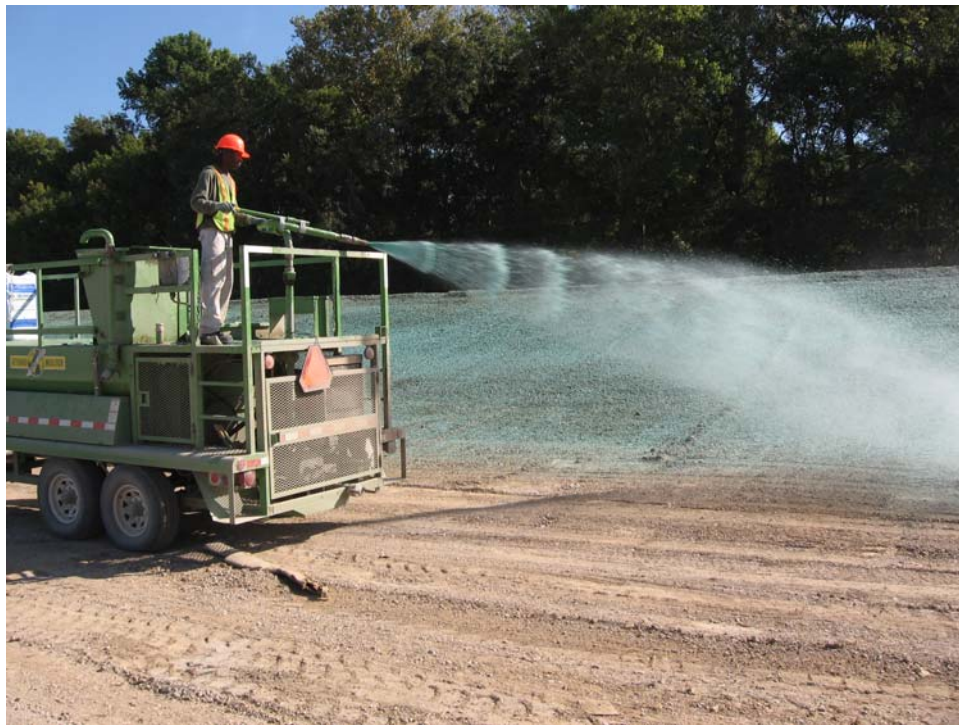
Photo 21: The process of hydro-mulching must be evenly sprayed to cover the required area.

Once all 4 armoring material were installed, the process of hydro-mulching took place on November 1, 2007. Hydro-mulching on all test areas consisted of approximately 1.2 acres of levee. The materials for this portion of the project consist of: 1 bag of hulled Bermuda grass seed, 1 bag of winter rye grass seed, and 54 bags of Enviroblend mulch. The hydro-mulching machine holds 100 gallons of water and was filled up 6 times, while adding 9 bags of mulch and 8lbs each of Bermuda and Rye grass seed per load. A rate of 2000lbs per acre was used. All armoring materials and test area were hydro-mulched on both sides of the levee project.

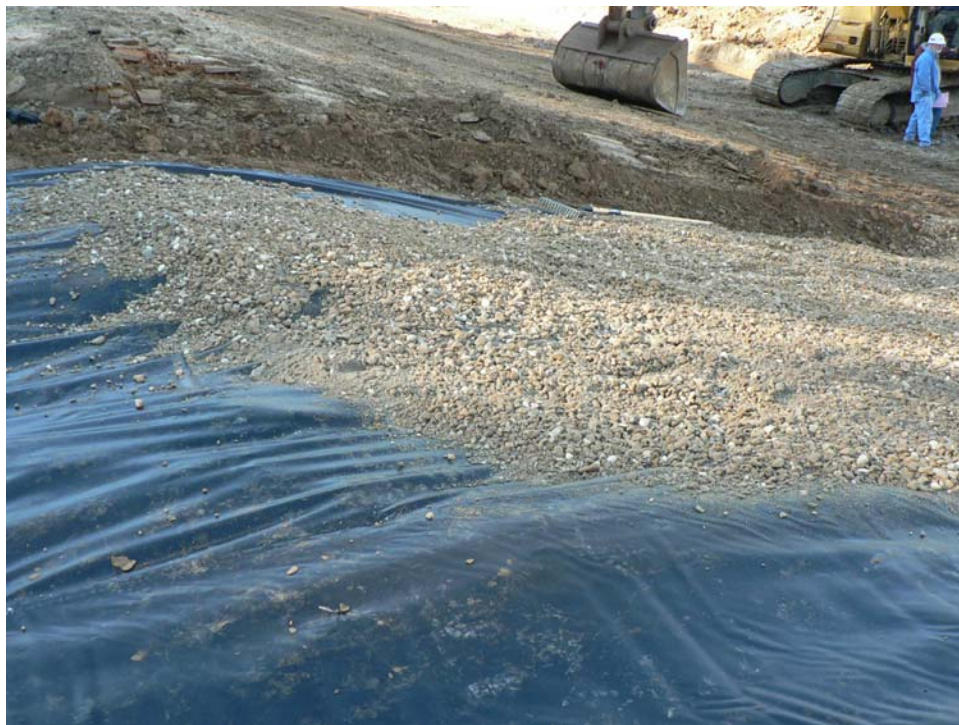
Photo 23: Here we see a filter fabric installed under the crushed stone.

Armortec Articulated Concrete Blocks are being offloaded. Six trucks were needed to deliver the quantity needed for this test section. The levee was graded 8" deeper than the rest of the levee reach to accommodate the blocks thickness so that the final levee grade would be even throughout the entire 500' study reach. All block dimensions are 17.4" x15.5". Each block is strung together by a continuous nylon rope to form a sheet which is 8' x 20'.

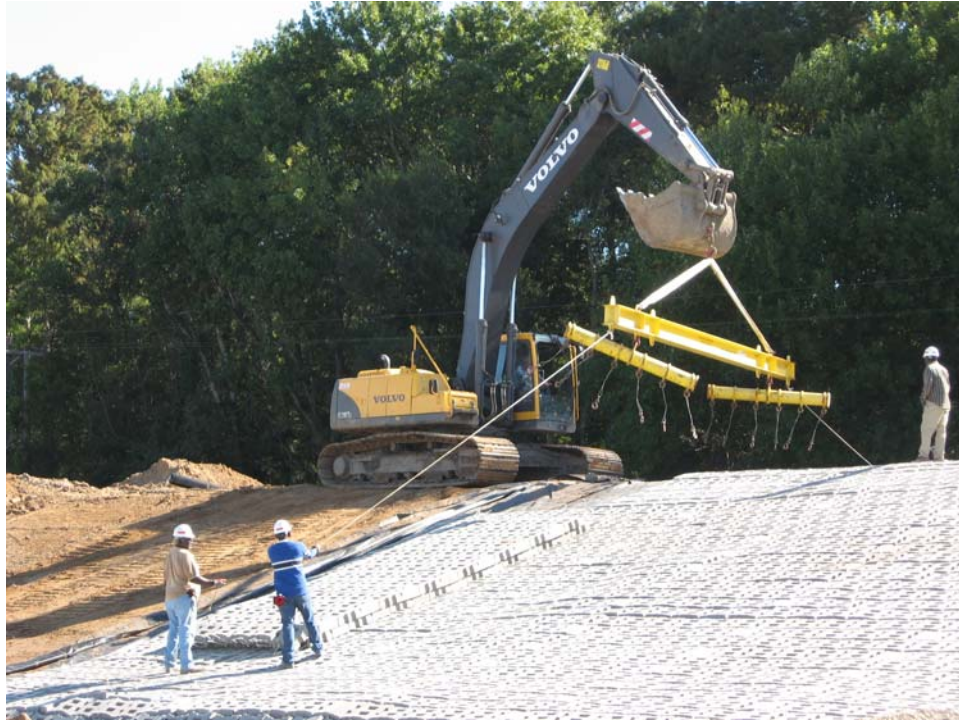
Photo 25: Blocks are installed at the crown with the spreader bar attached to the excavator.

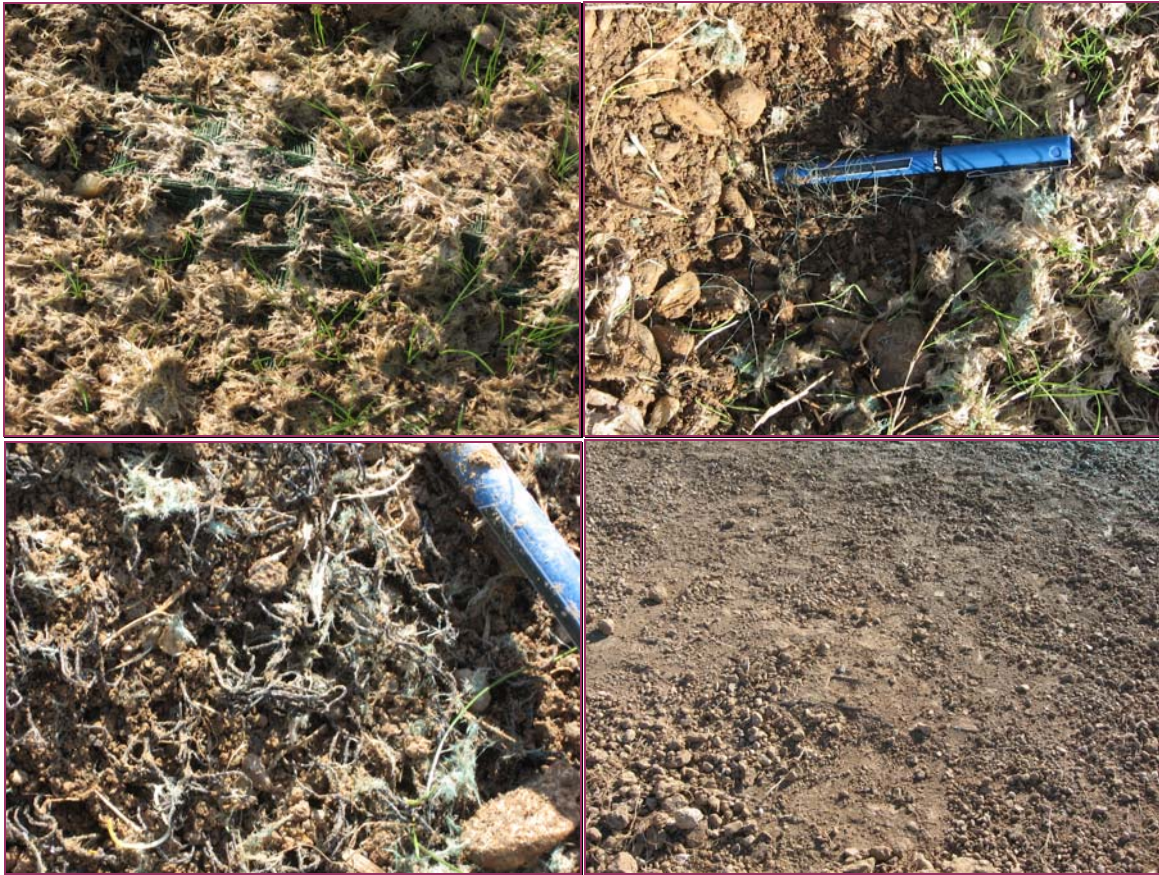
Photo 26: Four photos above show each product backfilled with about 1” topsoil.

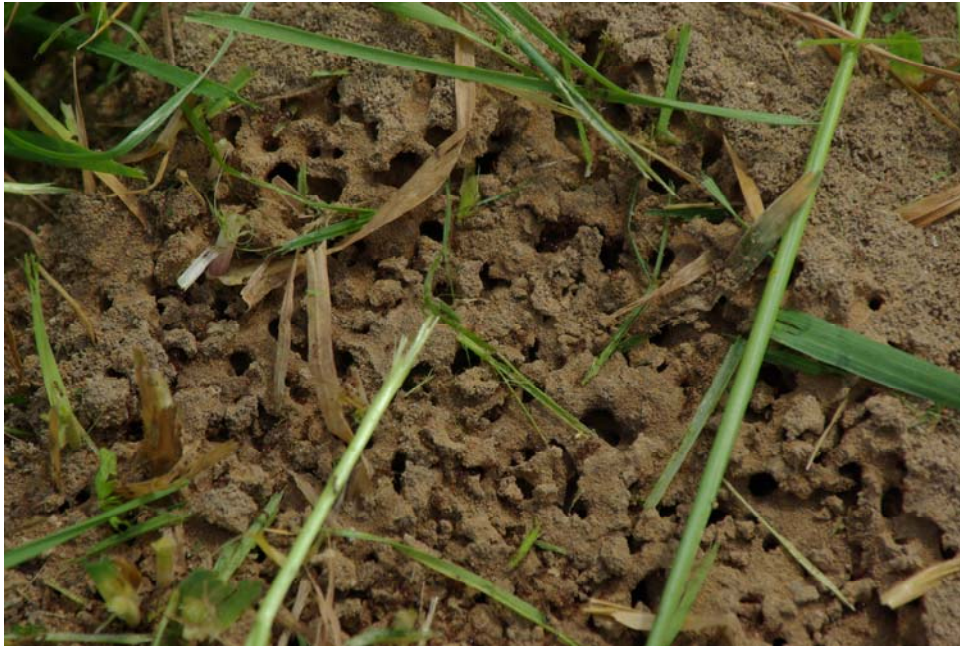
Photo 30: Observation of insects that may cause armoring stability problems.

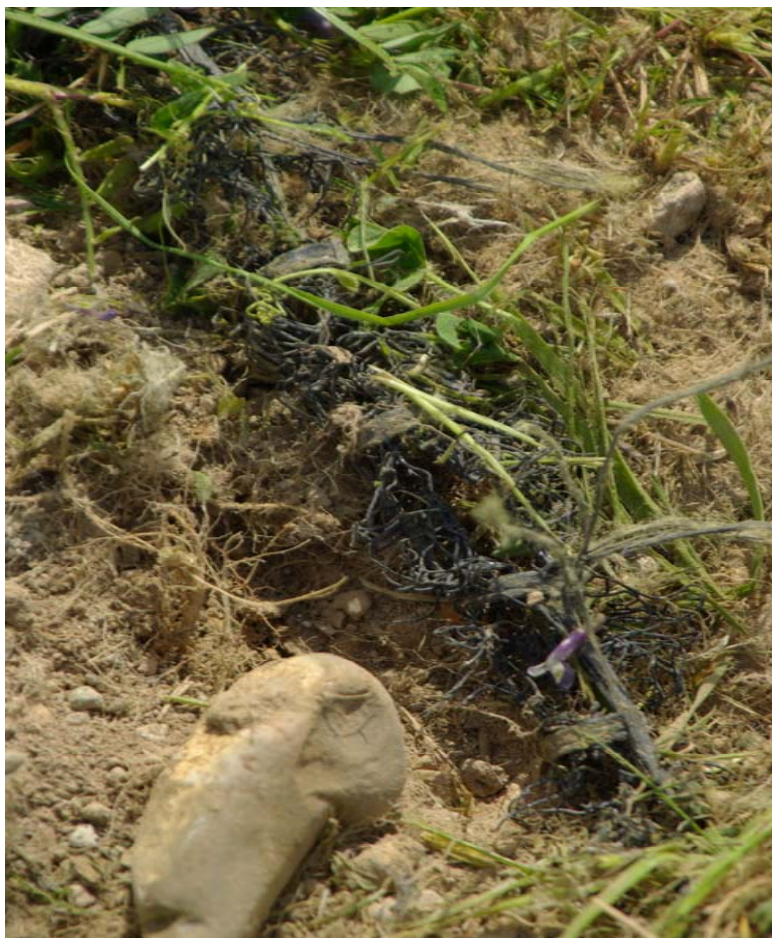
Photo 32: Signs of the Enkamat under distress after mowing.

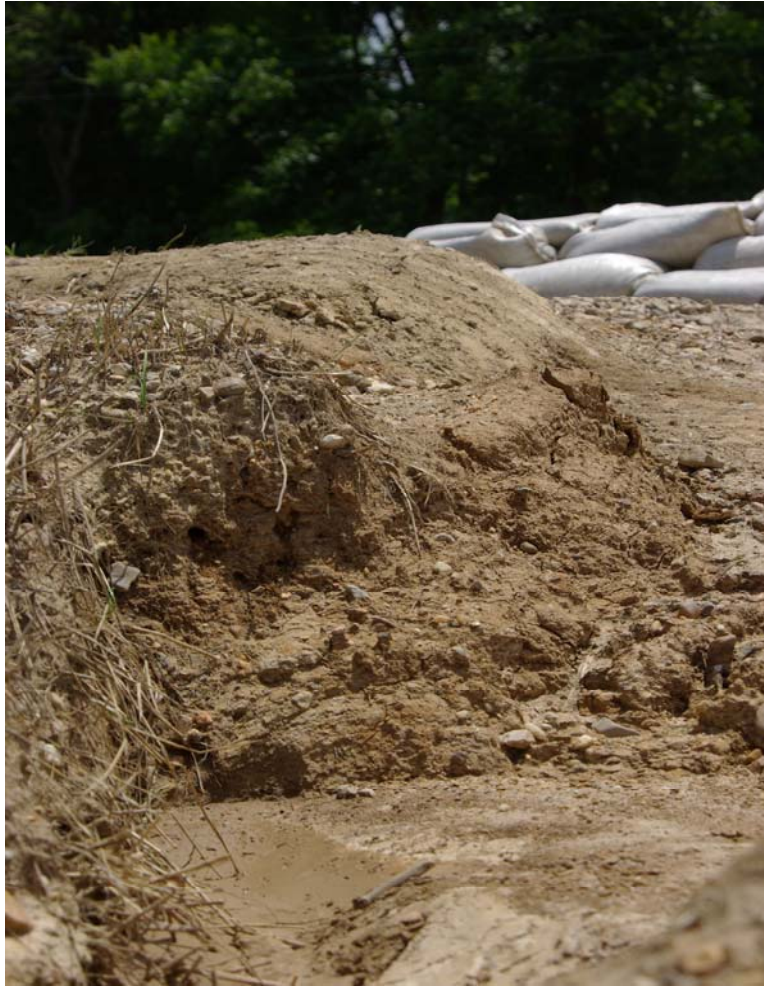
Photo 34: Grass only section of the levee alignment shows nearly 2 feet of scouring at the crown of the levee.

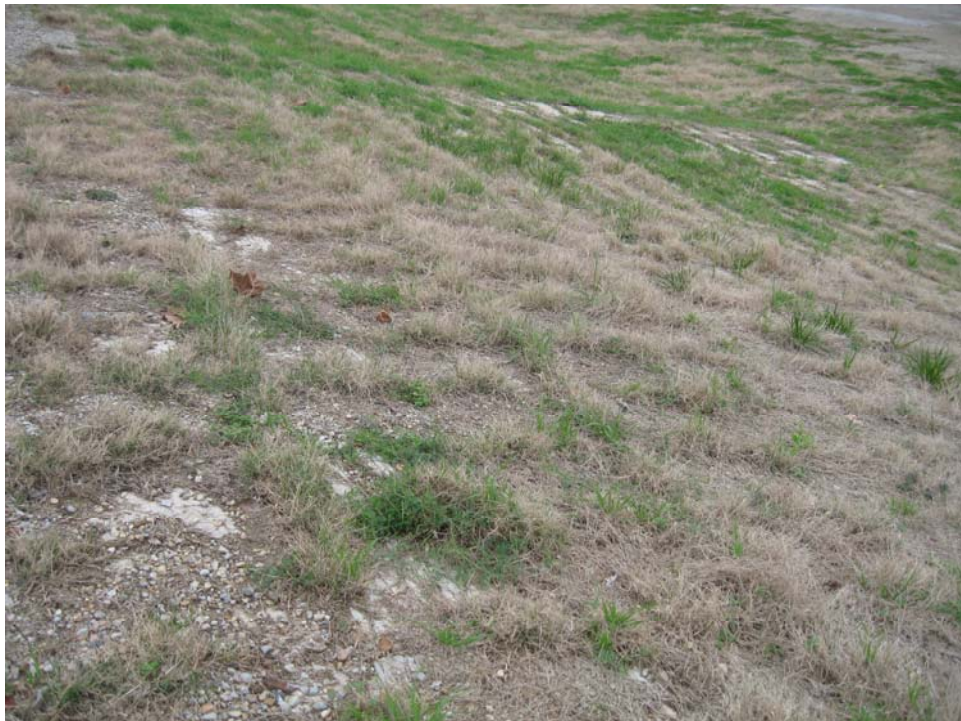
Photo 15: ACM grass growth is not healthy.
